# GROSSE ILE PARKWAY OVER TRENTON CHANNEL STRUCTURE NUMBER 12066 BRIDGE EVALUATION

AUGUST 2022

THE MANNIK & SMITH GROUP, INC.

Re: **Bridge Evaluation**

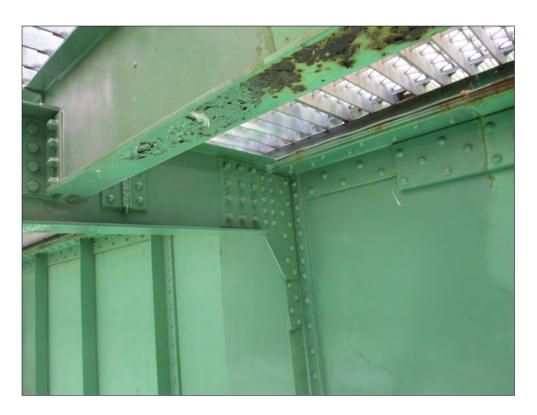
Span 6w, floorbeam 5w, bolted web repair.

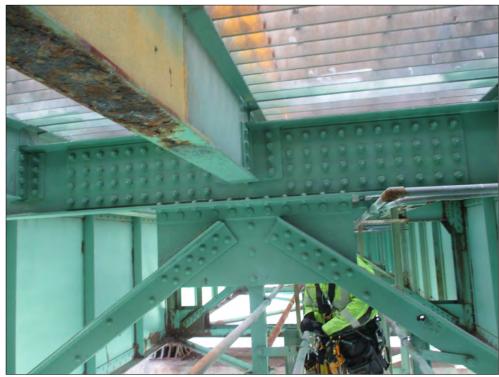
Span 7w, floorbeam 2w, bolted web and flange repair.

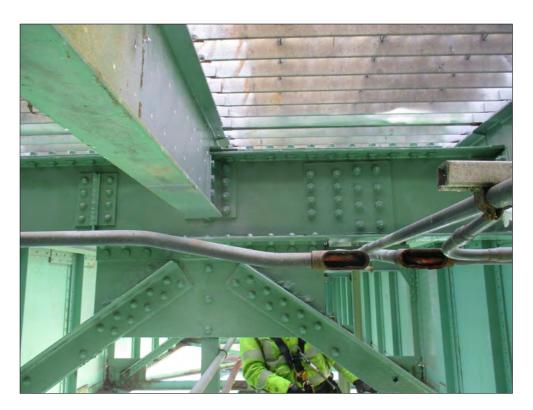
Span 7w,
Floorbeam/
stringer
connection,
bay 2w,
stringer 1s,
painted over
LOS

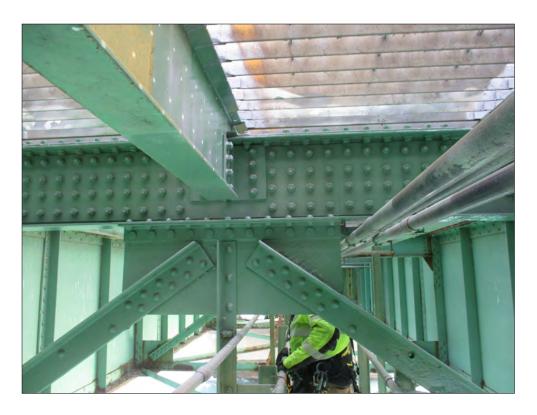
Span 7w, stringer 1s connection, bay 2w, stringer 1s, heavy LOS

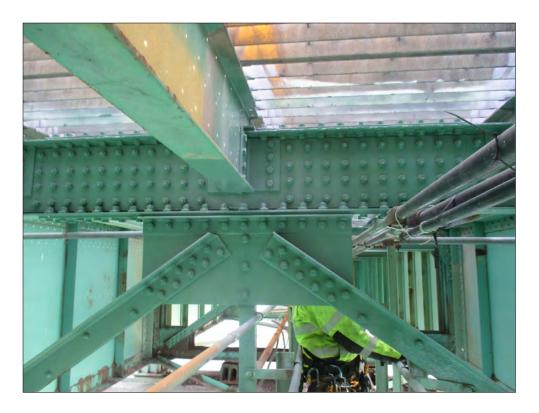
Span 8w, new floorbeam

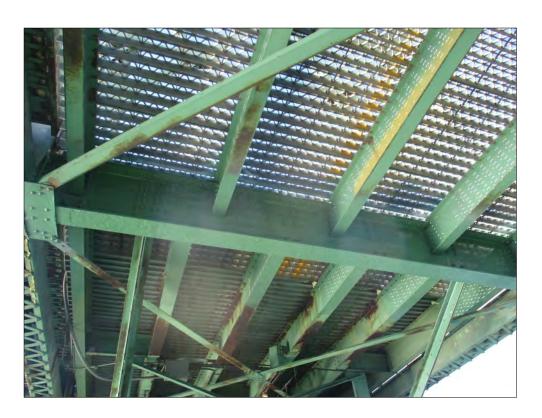
Span 9w, floorbeam 1w, bolted repair, stringer 2s

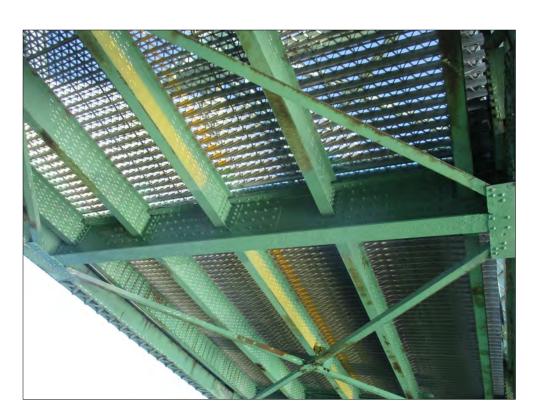
Span 9w, floorbeam 2w, bolted repair

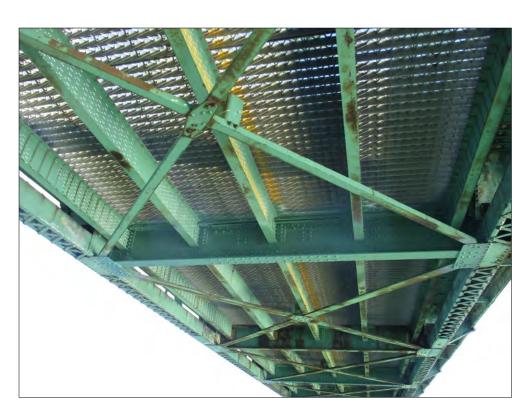
Span 9w, floorbeam 3w, bolted repair

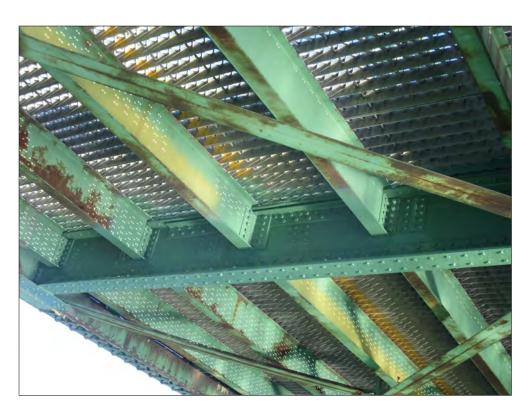
Span 9w, floorbeam 5w, bolted repair

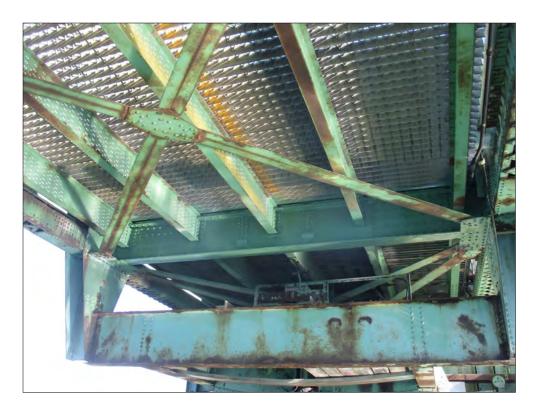
Span 9w, floorbeam 6w, bolted repair

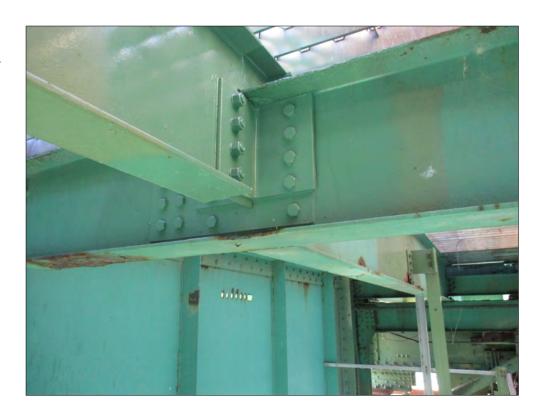
Span 11w, floorbeam 2w 1/2" wide hole at edge of bottom flange

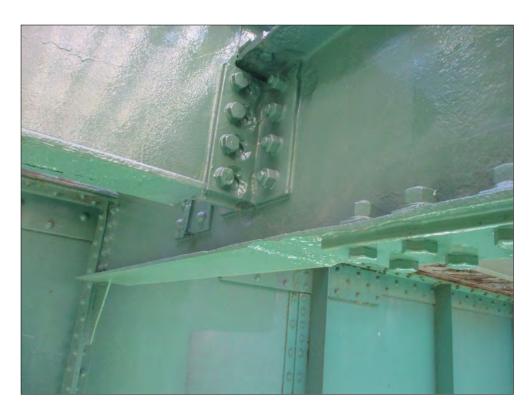
Span 12w, floorbeam 3w

Bottom flange thickness 0.22" adjacent to bolted repair

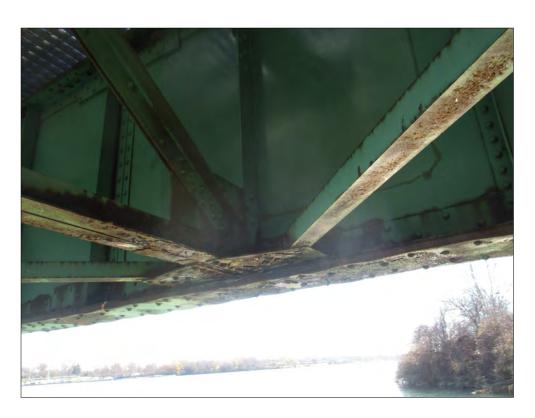
Span 1w, south girder, section loss at floorbeam 4w

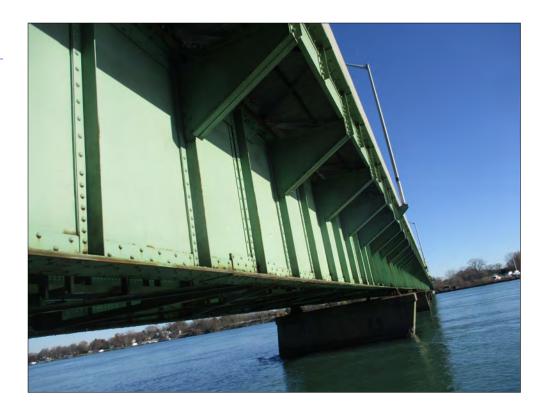
Span 2w, north girder, section loss at floorbeam 3w, 4w

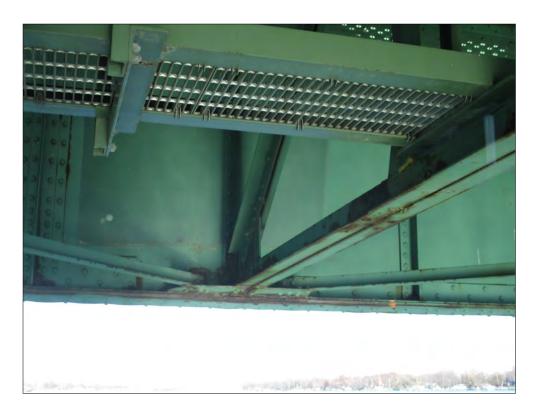
Span 6w, north girder, section loss at floorbeam 3w, 4w

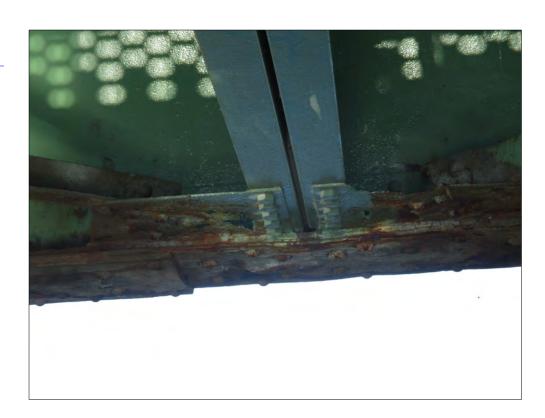
Span 7w, north girder, bottom flange, floorbeam 5w

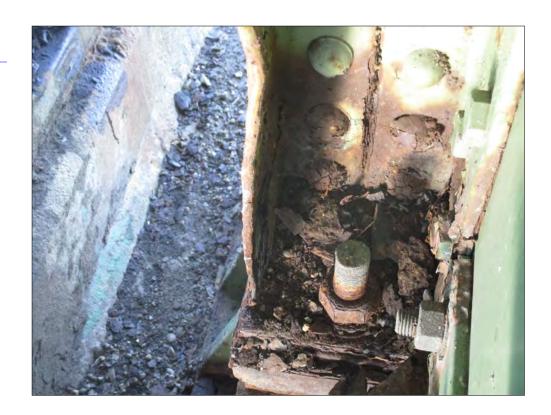
Bearing stiffener paper thin

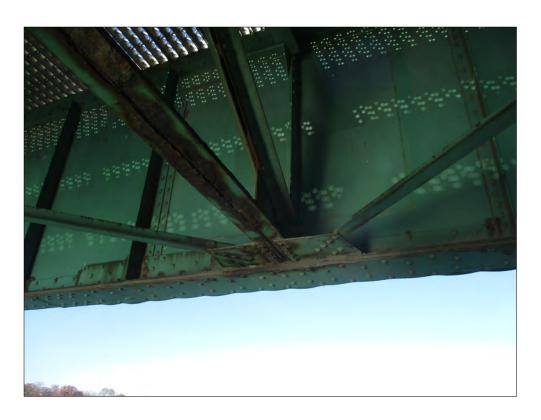
Span 12w, north girder, section loss at floorbeam 3w, 4w

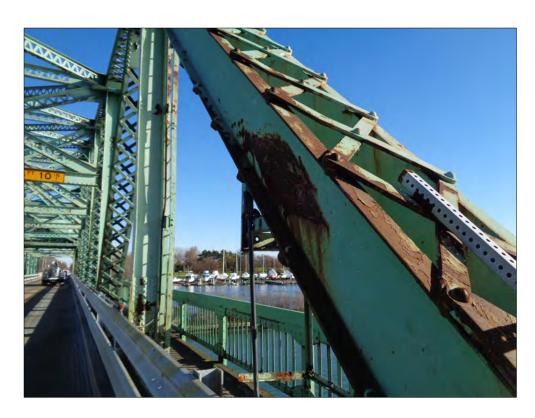
Span 9w, south truss, north face, diagonal  $L_0$  -  $U_1$  section loss

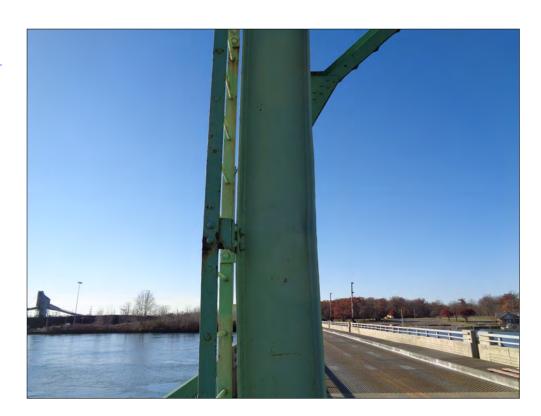
Span 9w, south truss, north face, vertical L<sub>1</sub> - U<sub>1</sub> rust crack

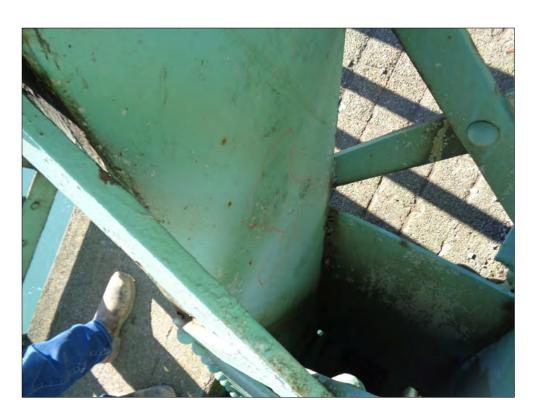
Span 9w, south truss, north face, diagonal  $U_3$  -  $L_4$ section loss

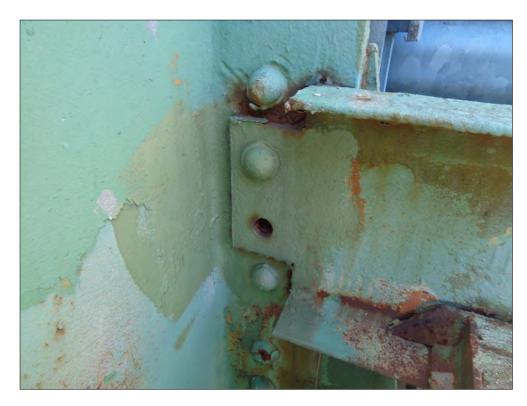
Span 9w, south truss, north face, lower gusset, vertical  $L_4$  -  $U_4$ missing rivets

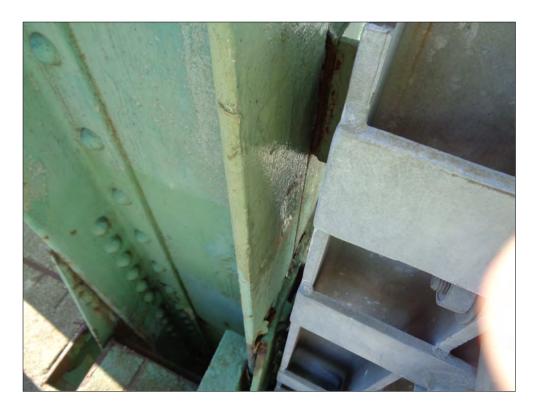
Span 9w, south truss, north face, lower gusset, vertical  $L_6$  -  $U_6$  pack rust

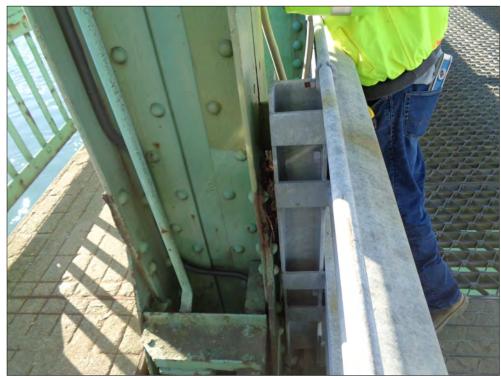
Span 9w, south truss, north face, lower gusset, vertical  $L_6$  -  $U_6$  pack rust

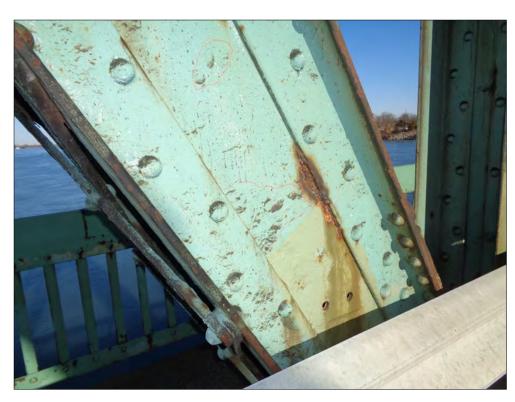
Span 9w, north truss, south face, lower gusset  $L_6$  -  $U_6$ missing rivets

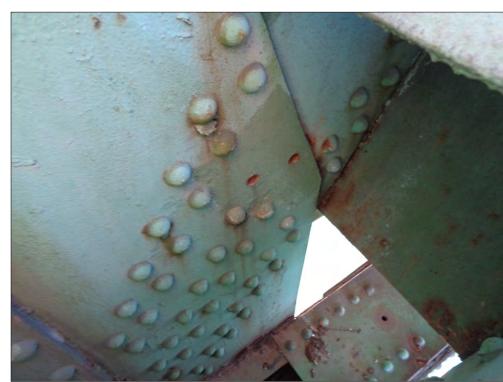
Span 9w, north truss, south face, lower gusset  $L_6$  -  $U_6$ missing rivets

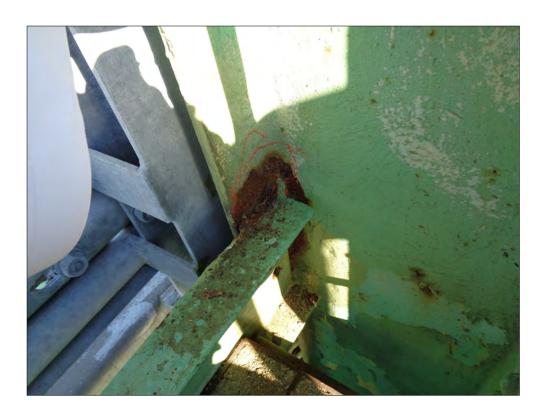
Span 10w, south truss, north face, vertical  $U_I$  -  $L_I$  section loss
