**UNDERWATER BRIDGE INSPECTION REPORT
GROSSE ILE PARKWAY OVER
TRENTON CHANNEL
STR 12006**

WAYNE COUNTY

NOVEMBER 9, 2021

GLEG FILE No: 1020-2-704

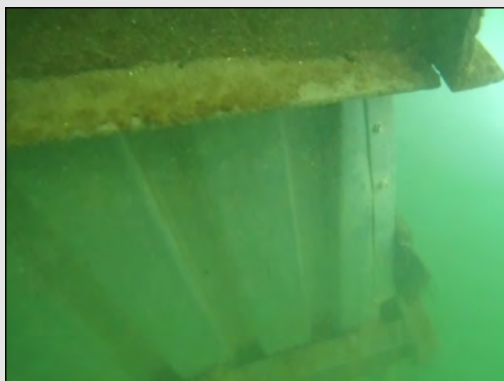
Steel stay-in-place forms and walers

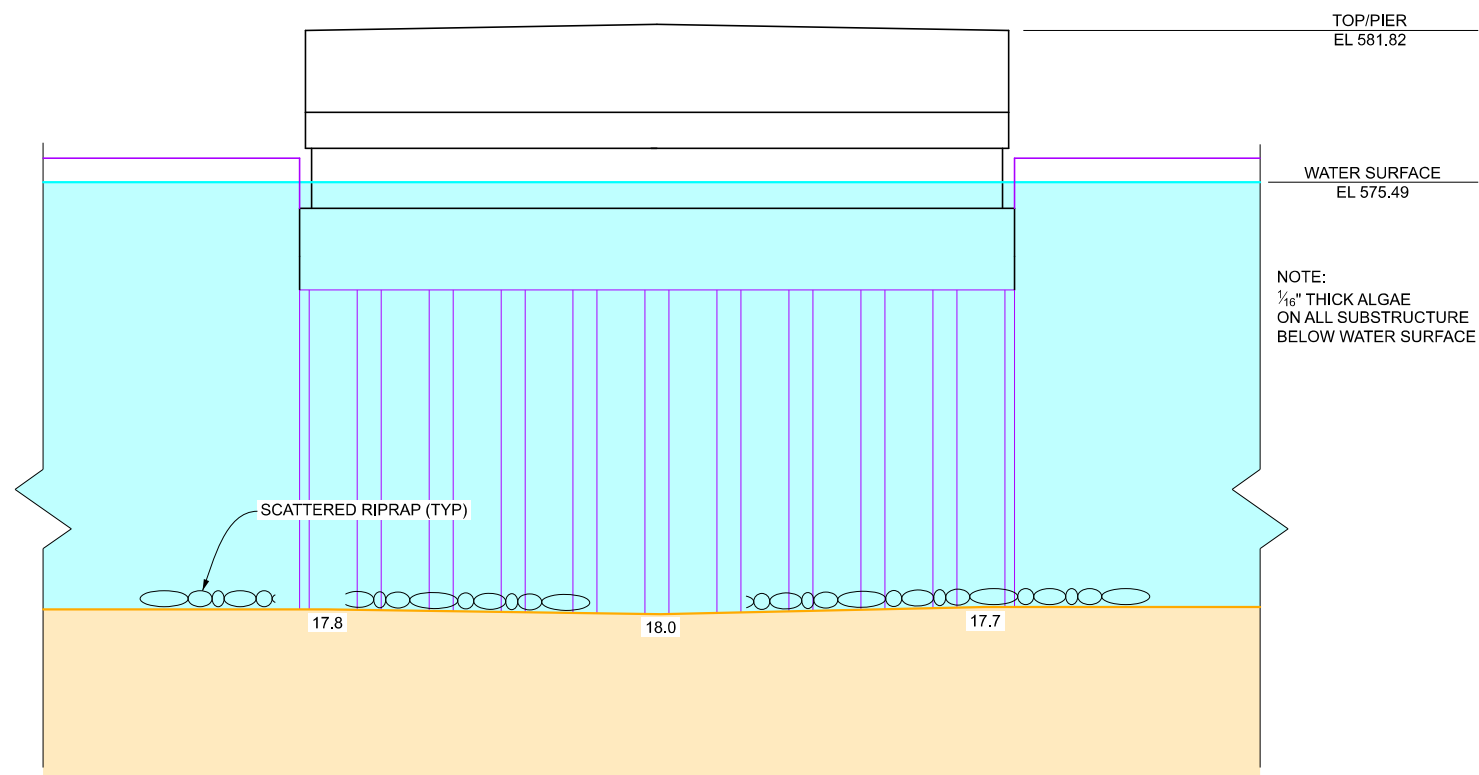
PIER 9W WEST ELEVATION

<p>Pier 9w (Refer to Substructure Elevation Drawings and Soundings Section)</p>	<ul style="list-style-type: none"> • Repairs made to previous timber cribbing, plywood sheeting, grout repair deterioration and loss of rock infill. • 6" rib-16 ga. steel sheeting on west and east elevations of pier (used as stay-in-place formwork). • C5x9 steel walers spaced at 2'-0" vertical spacing securing formwork. • Grout backfill inside steel formwork. • Uniform algae growth on concrete surfaces up to 1/16" thick. • Channel bottom consists of sand and scattered rocks 1' to 4' in diameter. 	<ul style="list-style-type: none"> • Repairs (concrete patches) made to previous spalled and delaminated areas on the pivot portion of the pier.
<p>Pier 9w - Pier Protection System (Refer to Substructure Elevation Drawings and Soundings Section)</p>	<ul style="list-style-type: none"> • Vertical timbers at upstream (north) end of pier have shifted, some have fallen onto channel bottom. • Horizontal timbers in southwest corner of cribbing have come loose and are unstable. • Fluctuations in the channel bottom have created gaps below the exterior plywood along both sides of the pier. The older interior cribbing is visible, but diver was not able to reach. • Deteriorated timbers members with loss of section 30%-70%. • Scattered riprap 1' to 4' in diameter on channel bottom around perimeter 	<ul style="list-style-type: none"> • Settlement of timber cribbing at north side of pier.

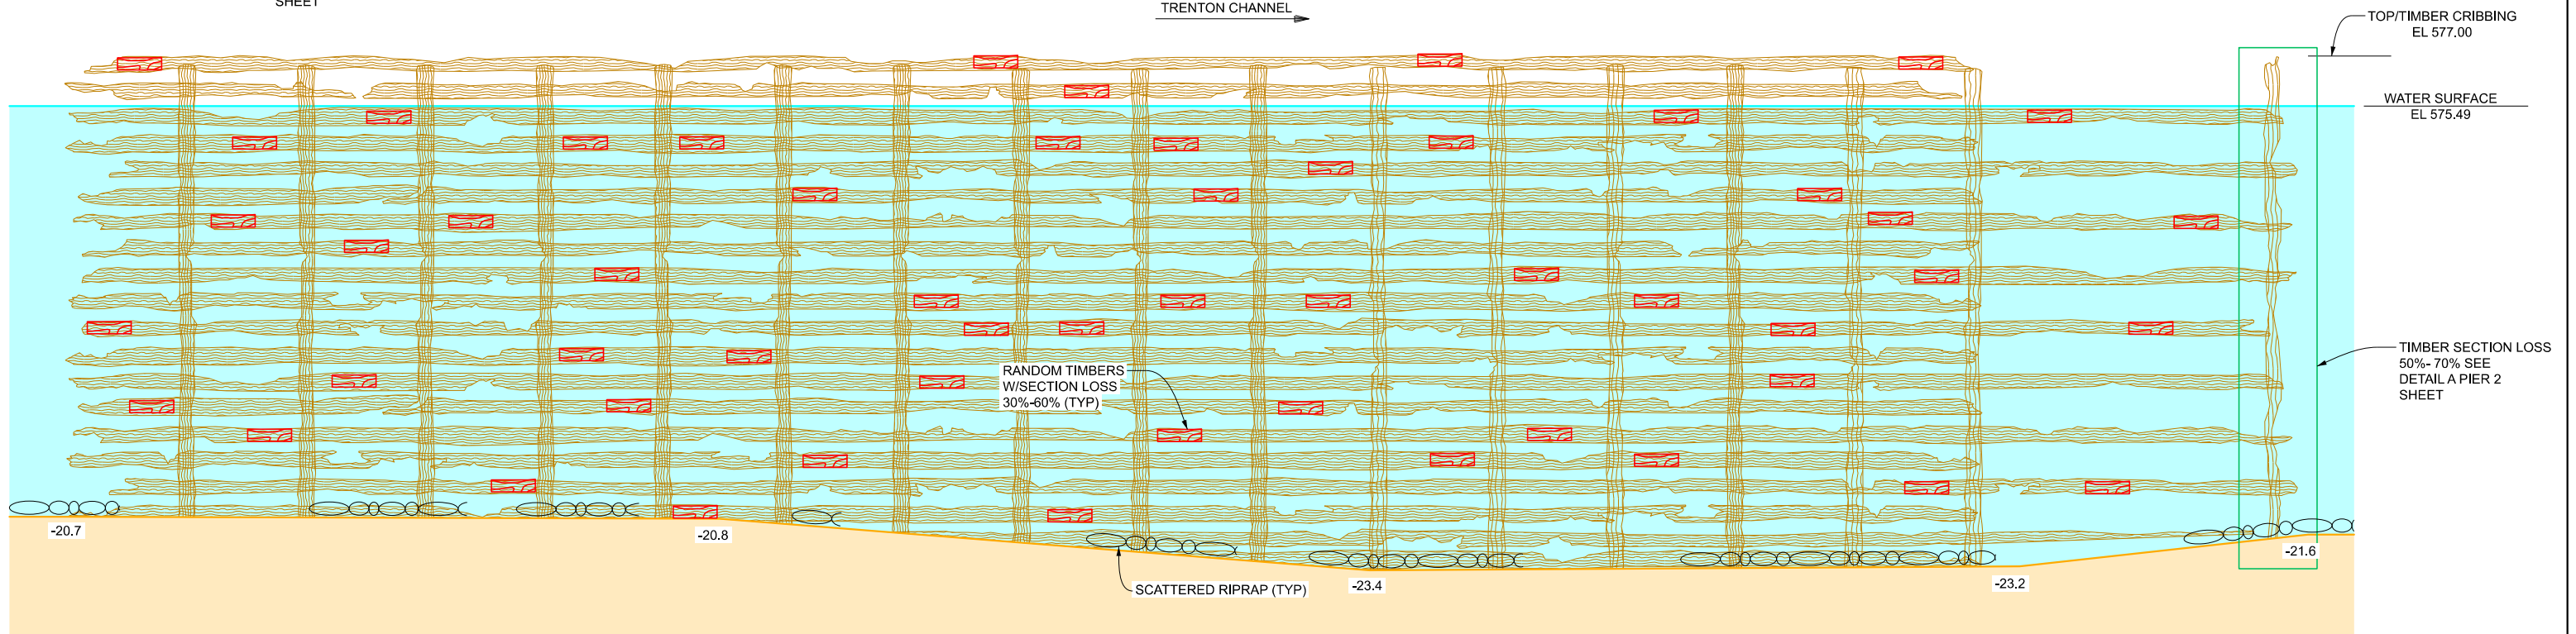
PIEW 9W TIMBER CRIBBING NORTH SIDE EAST ELEVATION

The timber cribbing pier protection system at pier 9w is in **poor condition**. The purpose of the system is to protect the bridge from impacts by vessels and also to identify the navigable channel. The protection system has the visual appearance of sinking, especially at the north end (upstream end). During the 2021, 2020, 2019, and 2017 underwater inspections, water levels have been higher than in older inspections. The high water levels contribute to the sinking appearance, however the extensive deterioration of the pier protection cribbing below water, and failed previous repairs are contributing to the settlement of the pier protection system.

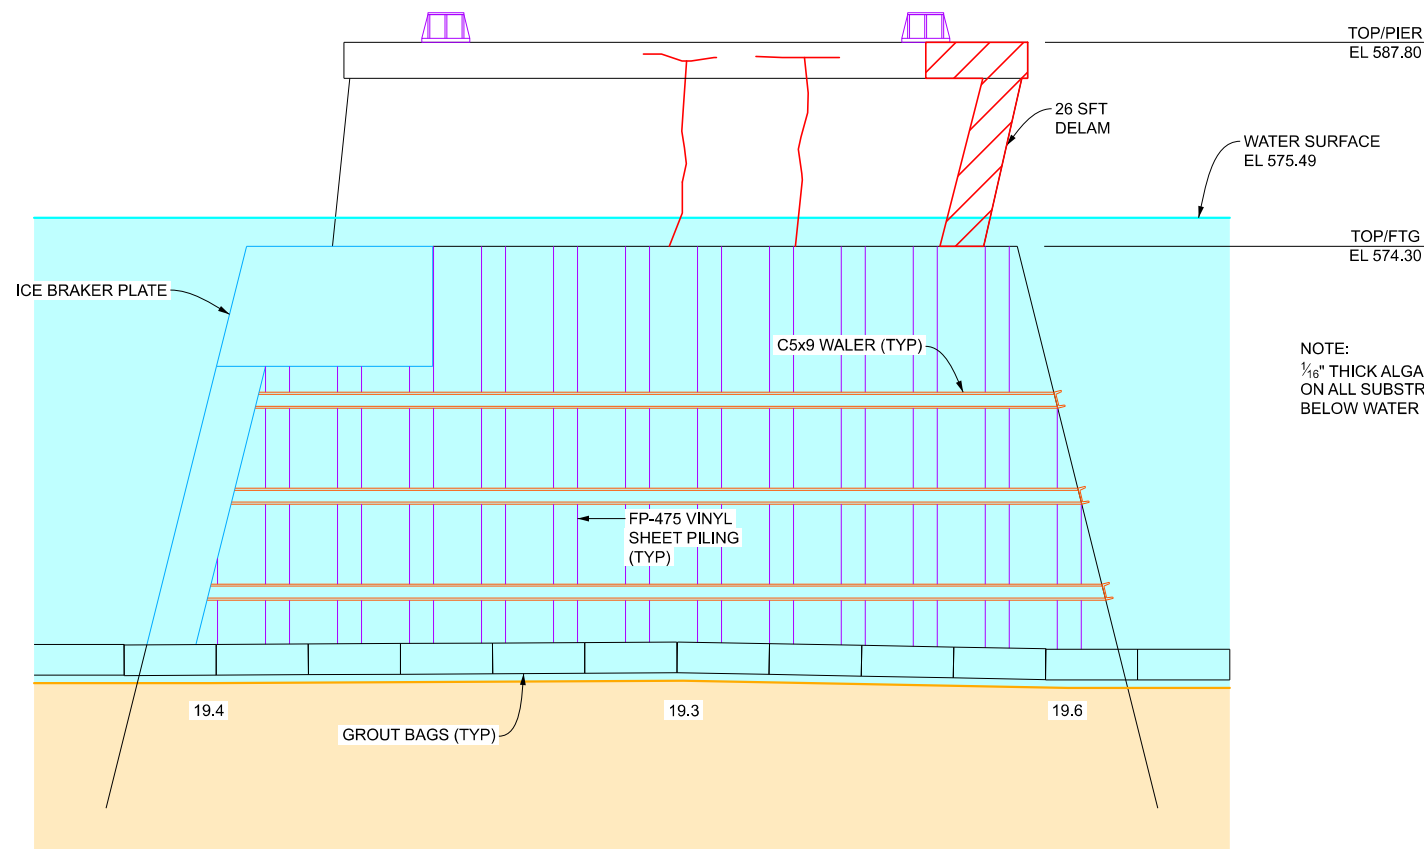
PIER 10W WEST ELEVATION

Substructure Unit	Observations Below the Waterline	Observations Above the Waterline
<p>Pier 10w</p> <p>(Refer to Substructure Elevation Drawings and Soundings Section)</p>	<ul style="list-style-type: none"> • Repairs made to previous timber cribbing deterioration and loss of rock infill. • FP-475 vinyl sheeting surrounds pier (used as stay-in-place formwork). • C5x9 steel walers spaced at 2'-0" vertical spacing securing formwork. • Grout backfill inside steel formwork. • Steel ice breaker plate at upstream end, extending 5' below waterline. • Smaller ice steel ice breaker plate extends to channel bottom. • Grout bags along channel bottom. • 12 sft spall at south end, 75% is above waterline. • 1 sft spall at north end, 50% is above waterline. 10 sft area of 4" deep scaling at north end, 50% is above waterline. • Vertical cracks in west and east elevations extend below waterline to top of footing elevation. • Uniform algae growth on concrete surfaces up to 1/16" thick. • Channel bottom consists of grout bags, sand and scattered rocks up to 1' diameter. 	<ul style="list-style-type: none"> • South end: 12 sft spall, 25% extends below waterline. • North end: 1 sft spall, 50% extends below waterline. 10 sft area of 4" deep scaling, 50% extends below waterline. • West elevation: 26 sft area of delamination in south end of pier wall and bolster area. Vertical and horizontal cracking in pier wall and bolster area. • East elevation: 4 sft spall in pier wall. Vertical cracks in pier wall.

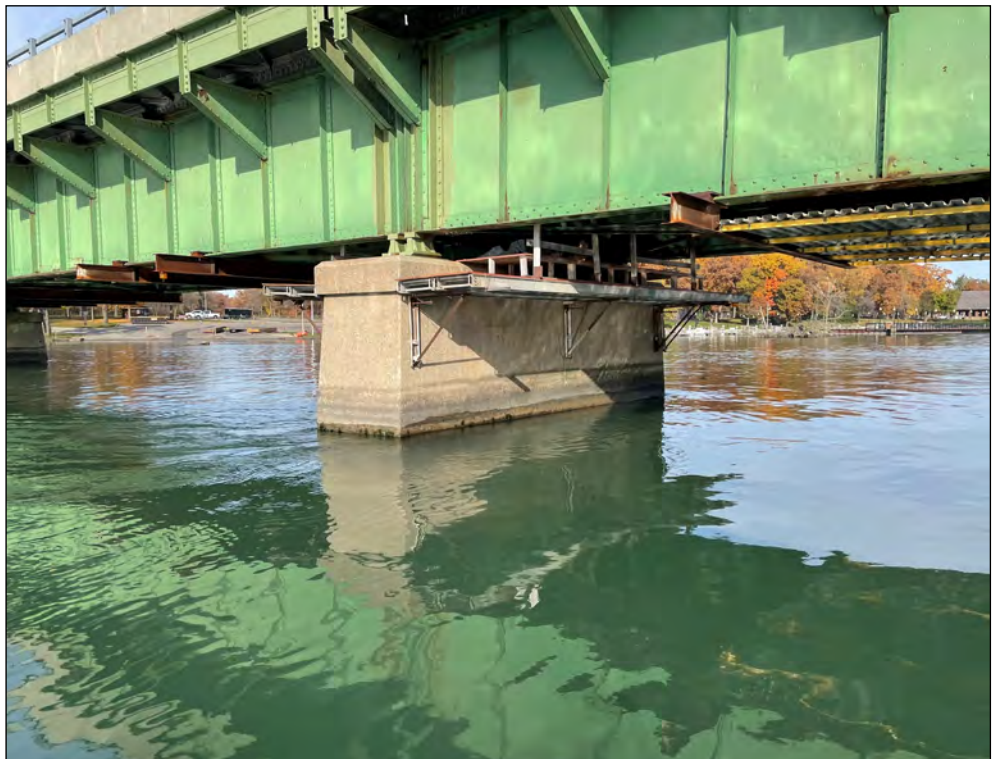
*Pier 3w,
horizontal
crack in
footing, typical
west and east
elevations*

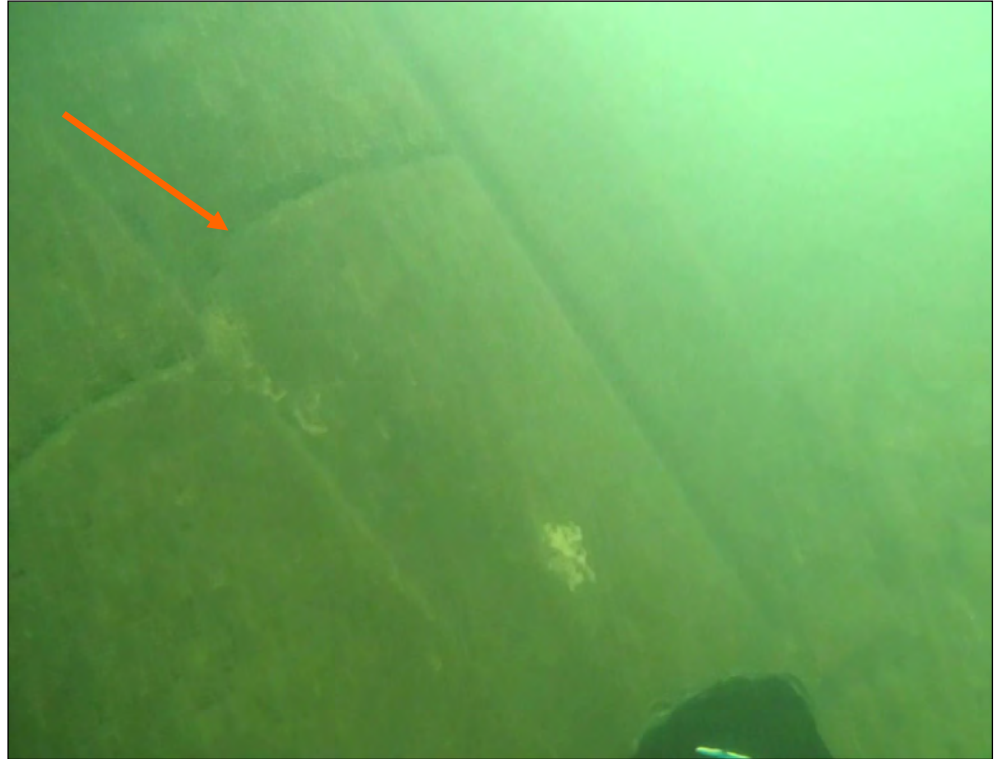
*Pier 3w, typical
condition of
exposed footing*

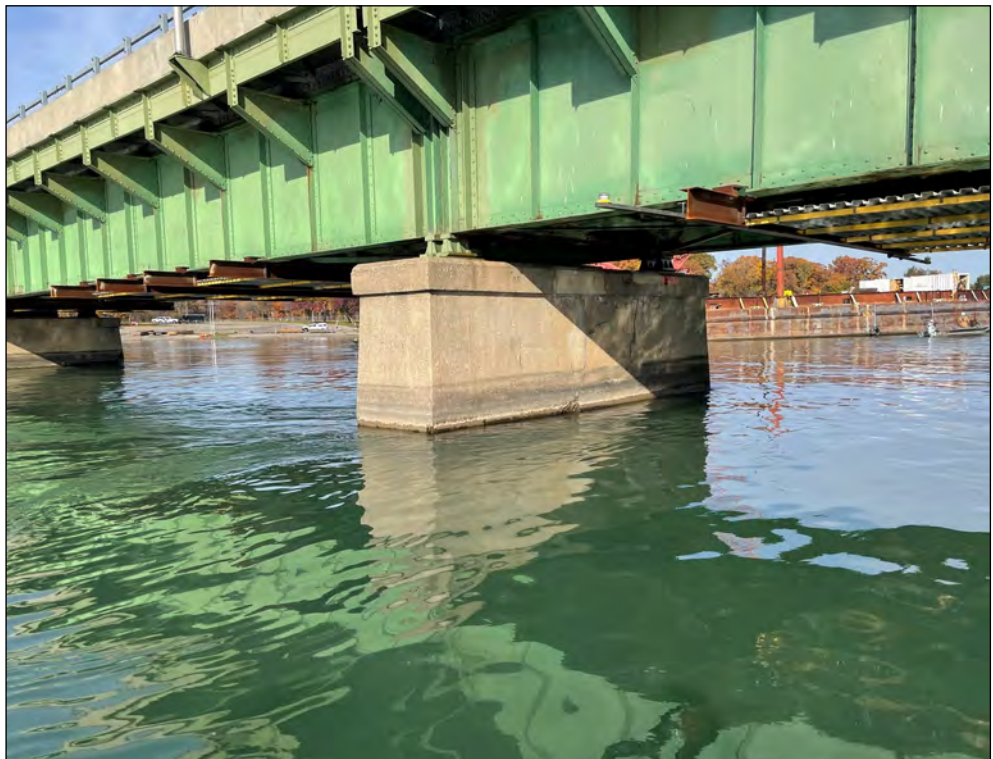
*Pier 5w, open
crack in
footing, typical
west and east
elevations*

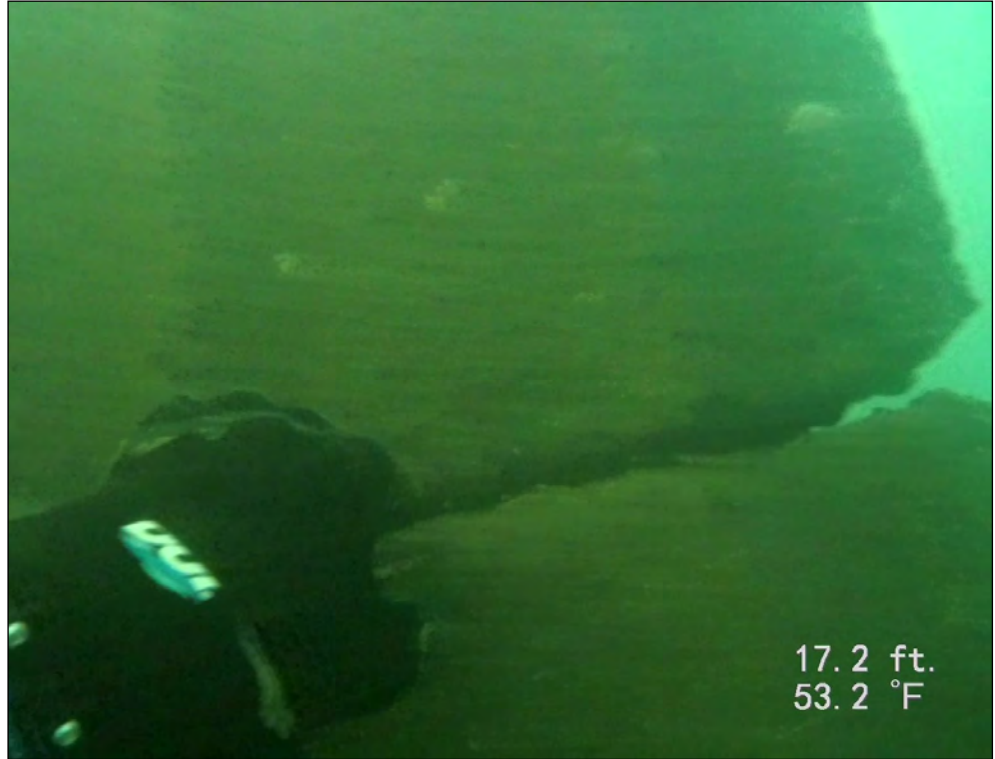
*Pier 5w, open
crack in
footing, typical
west and east
elevations*
