**UNDERWATER BRIDGE INSPECTION REPORT
GROSSE ILE PARKWAY OVER
TRENTON CHANNEL
STR 12006**

WAYNE COUNTY

NOVEMBER 9, 2021

GLEG FILE No: 1020-2-704

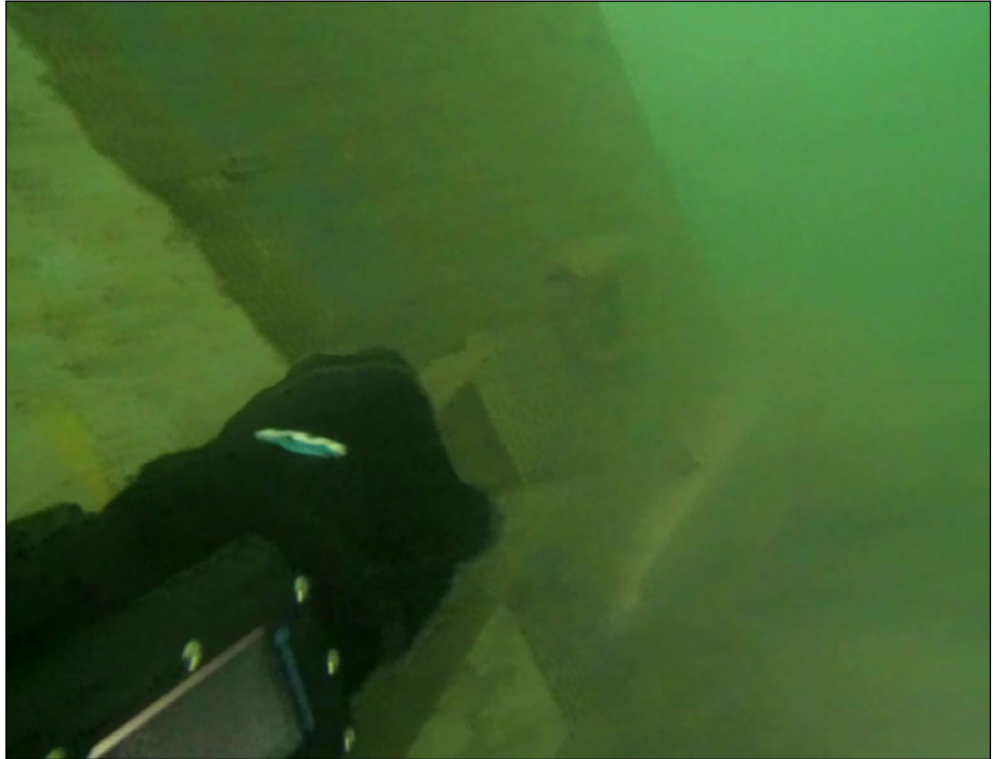
*Pier 2w, steel
ice breaker at
channel
bottom, typical*

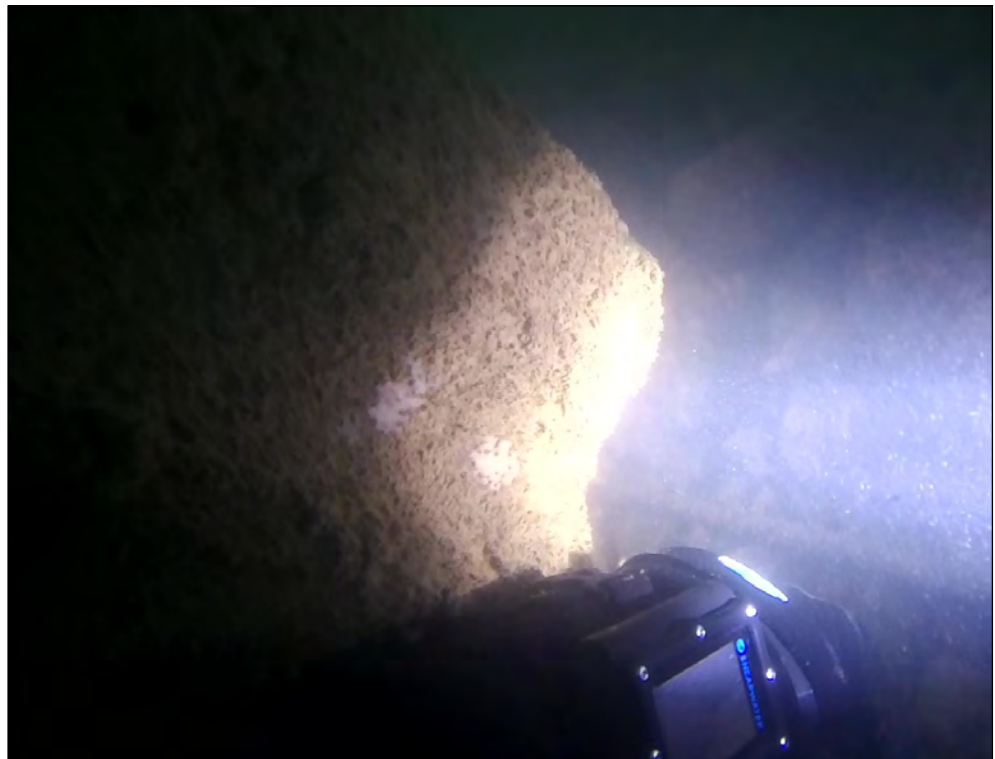
*Pier 3w, typical
condition of
exposed footing*

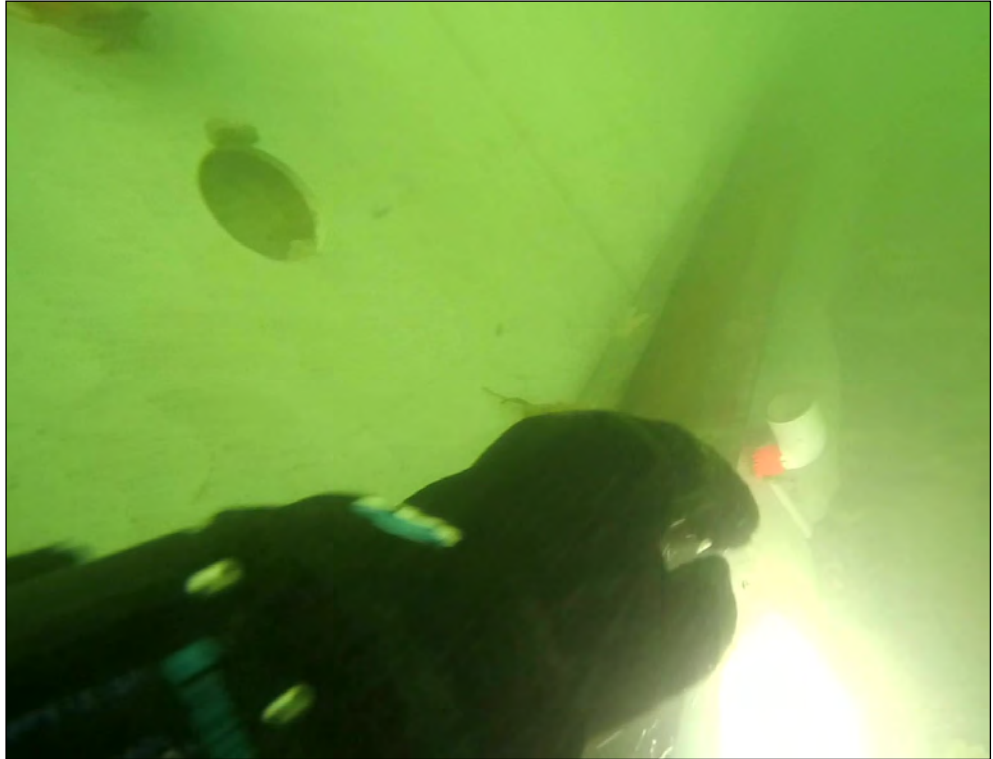
*Pier 4w, vinyl
sheeting at
channel
bottom, typical*

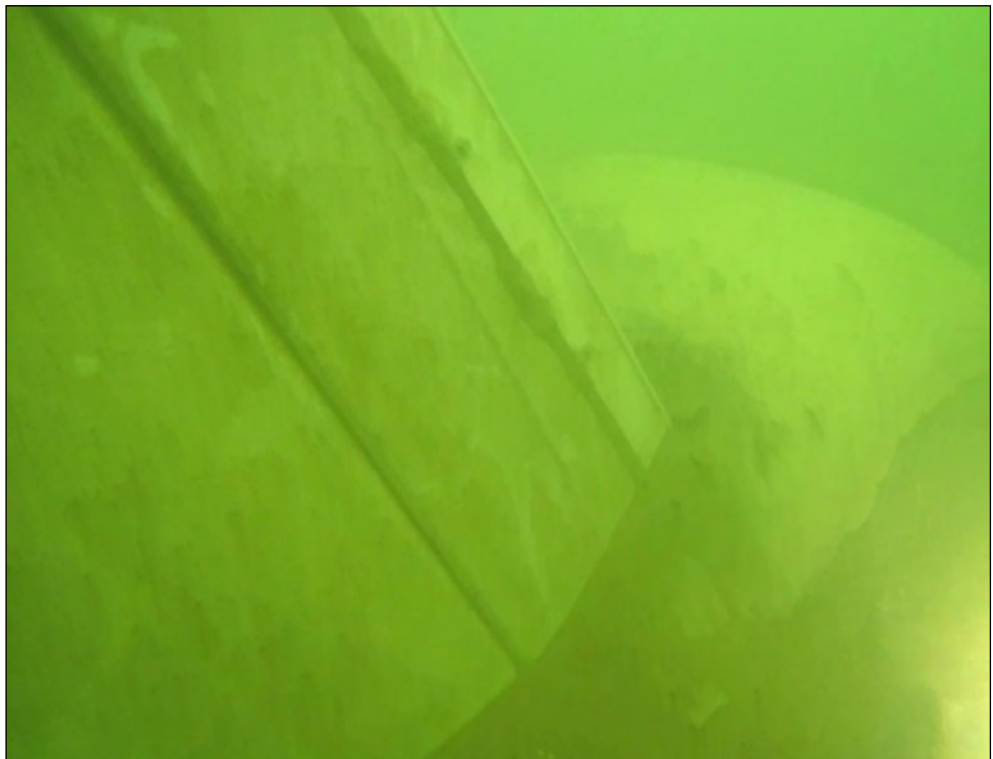
*Pier 4w, vinyl
sheeting and
grout bags at
channel
bottom, typical*

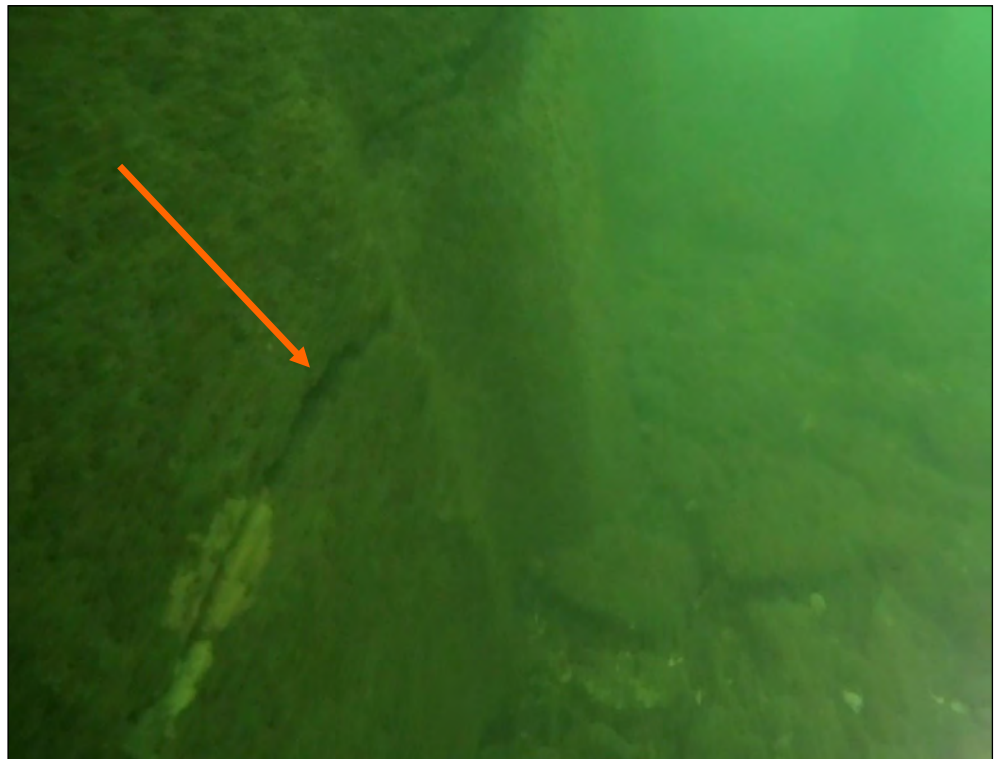
*Pier 5w, open
crack in
footing, typical
west and east
elevations*

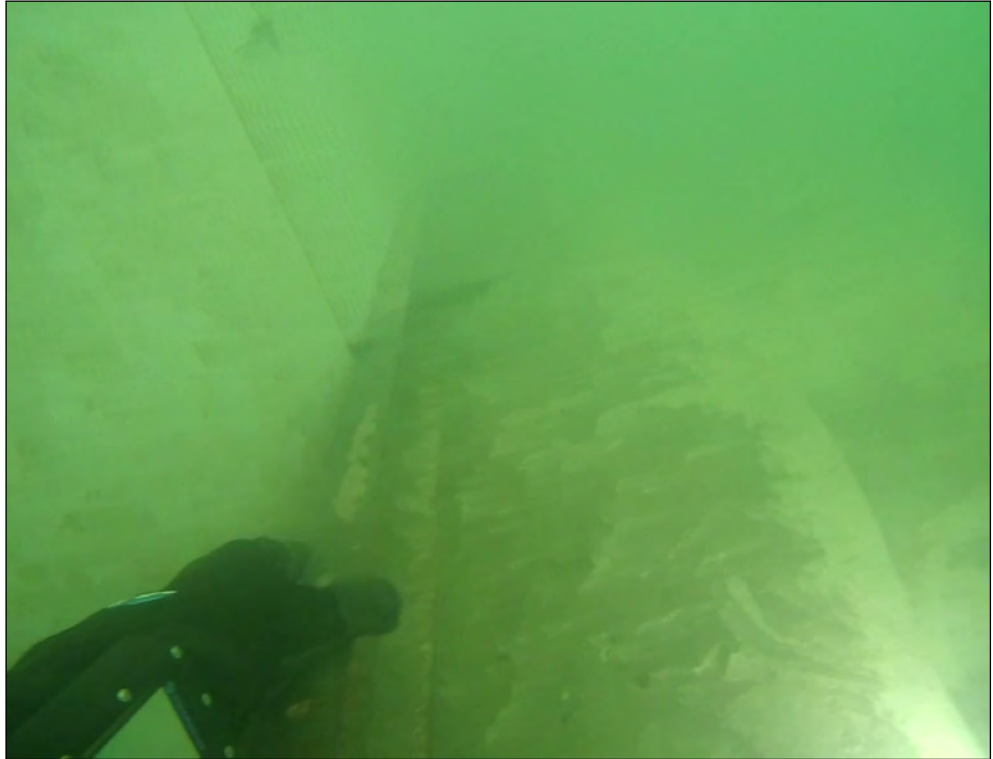
Pier 6w, grout bags and vinyl sheeting at channel bottom, typical

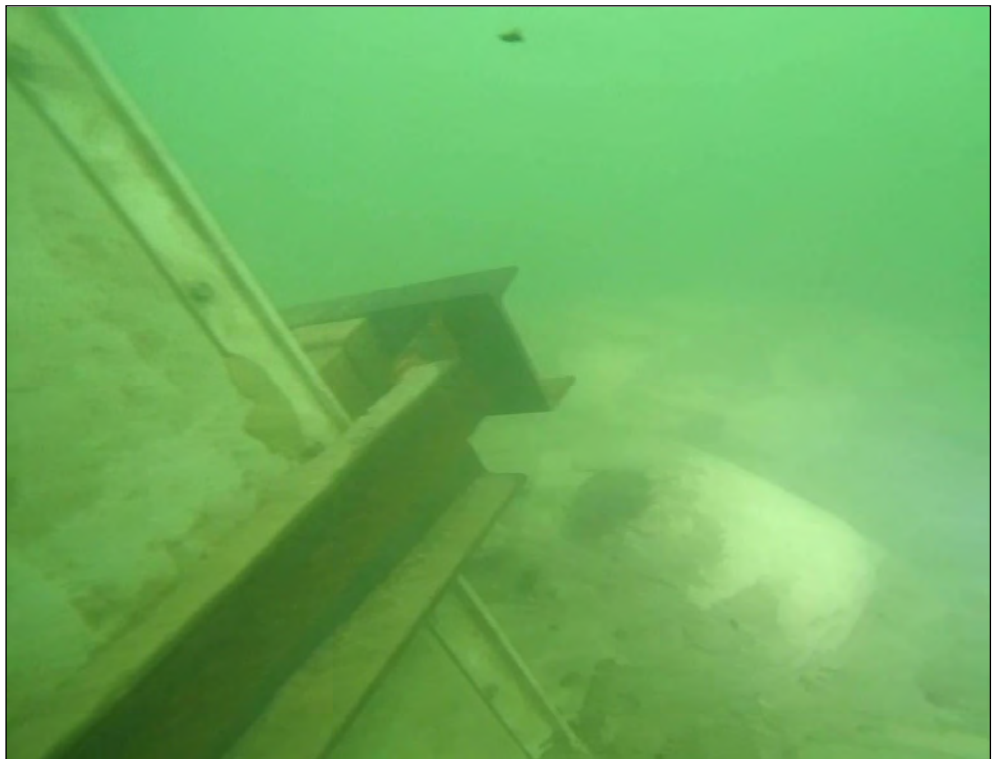
Pier 6w, corner of vinyl sheeting, steel walers and grout bags at channel bottom, typical

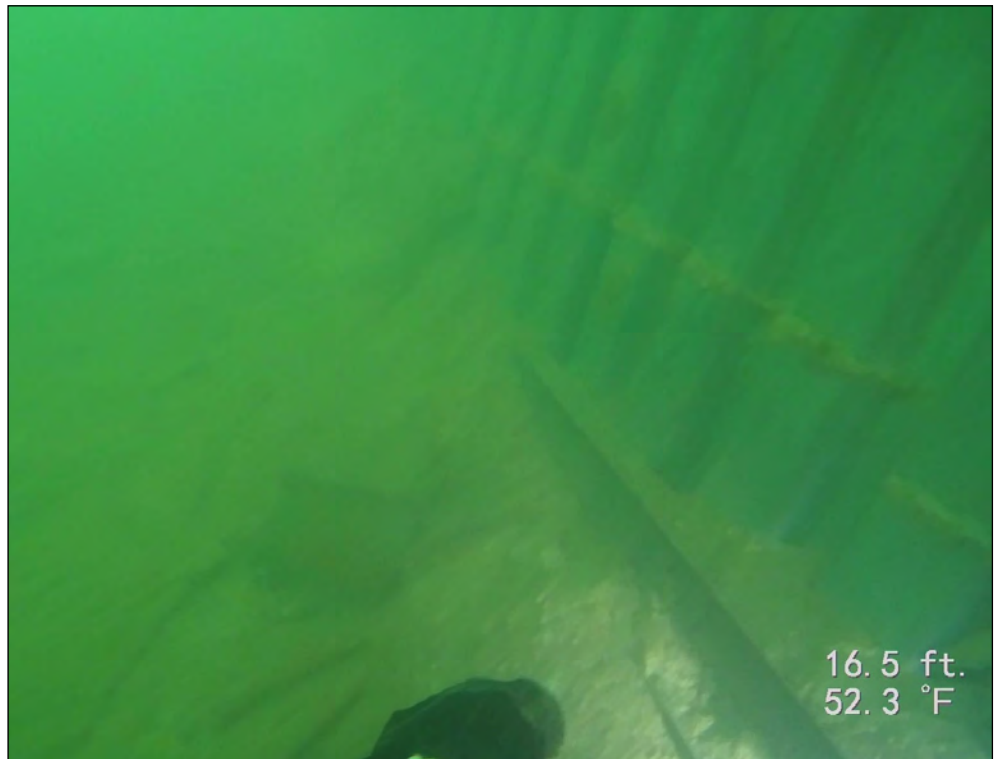
*Pier 8w, steel
sheeting and
steel walers at
channel
bottom, typical*

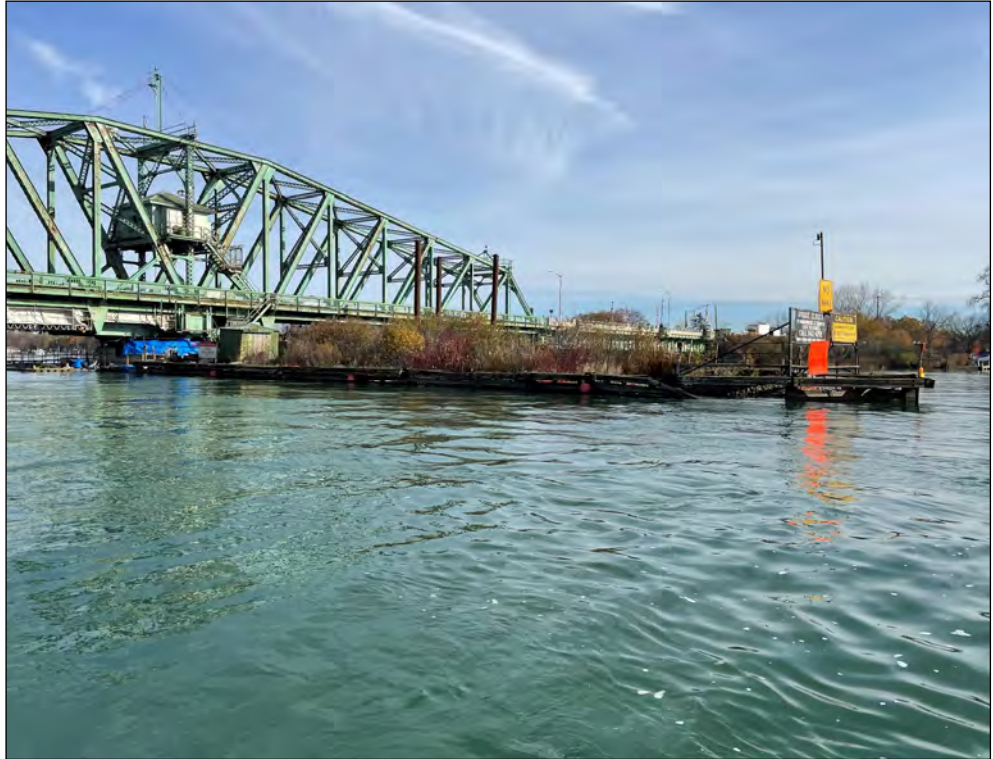
*Pier 9w,
southwest
timber fender*

H	Replace or retrofit the pier protection system at the pivot Pier 9W, both north and south ends. Recommend destructive testing such as cores be taken for retrofit design.
---	---

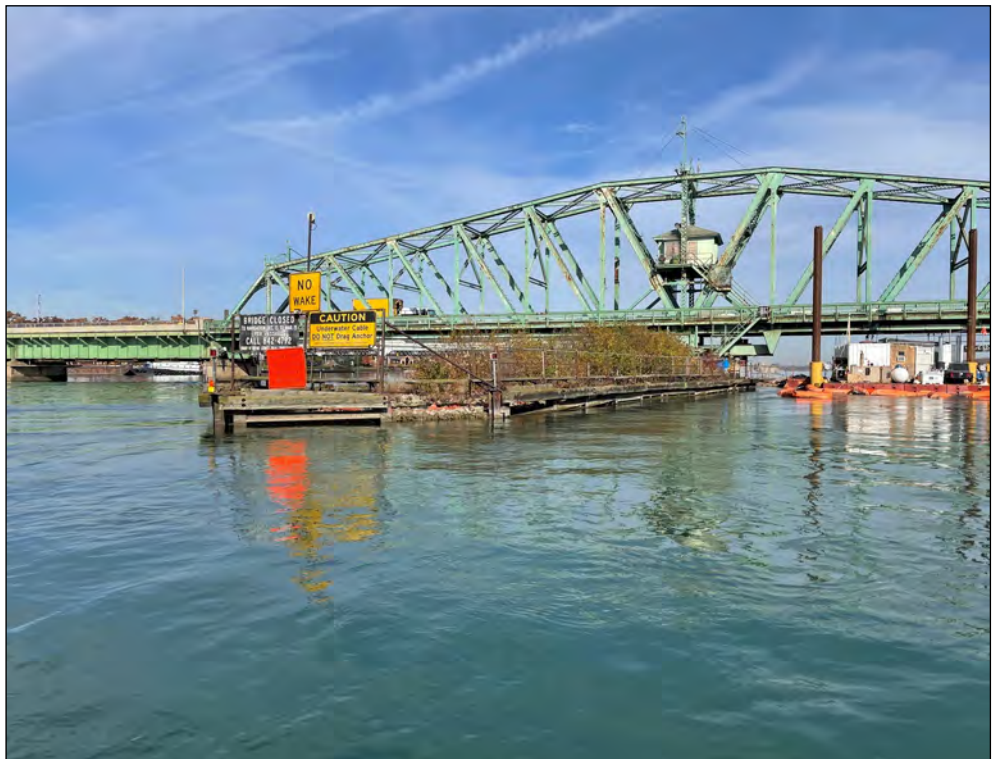
*Pier 9w,
southeast
timber fender*

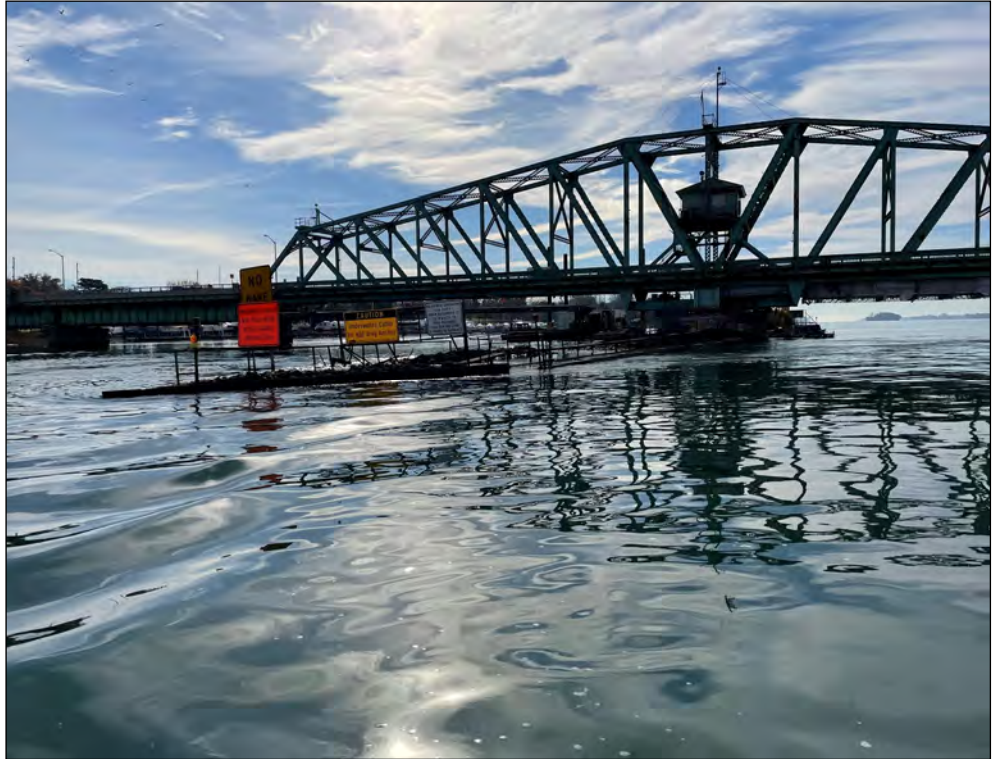
*Pier 9w,
northwest
timber fender*

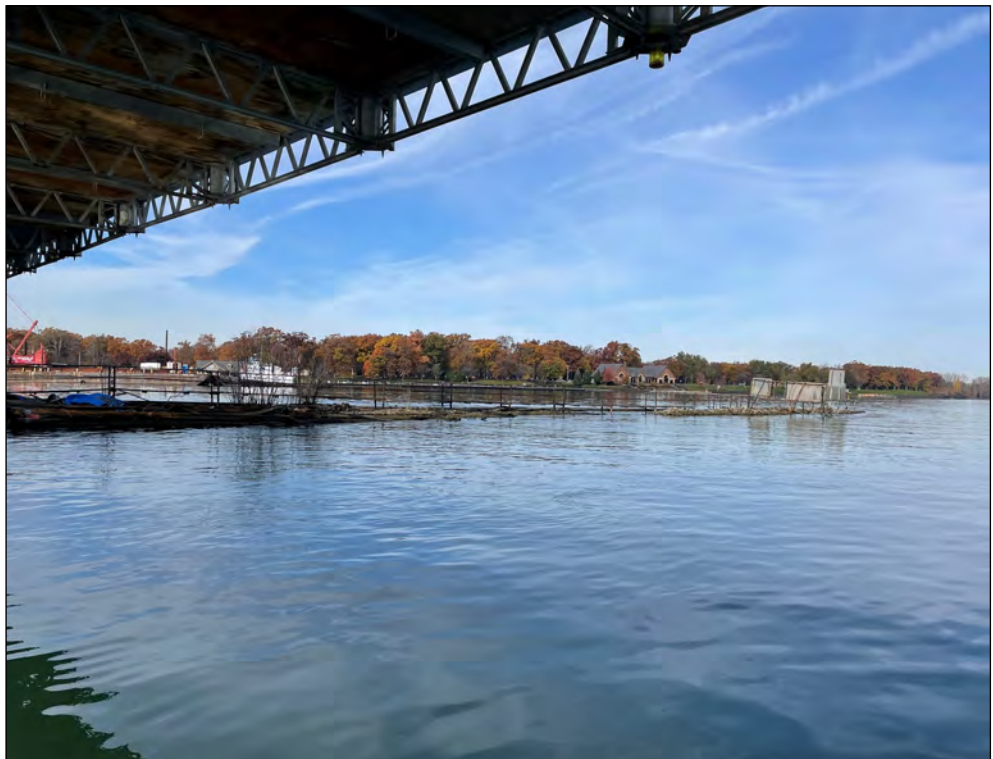
*Pier 9w,
northeast
timber fender*

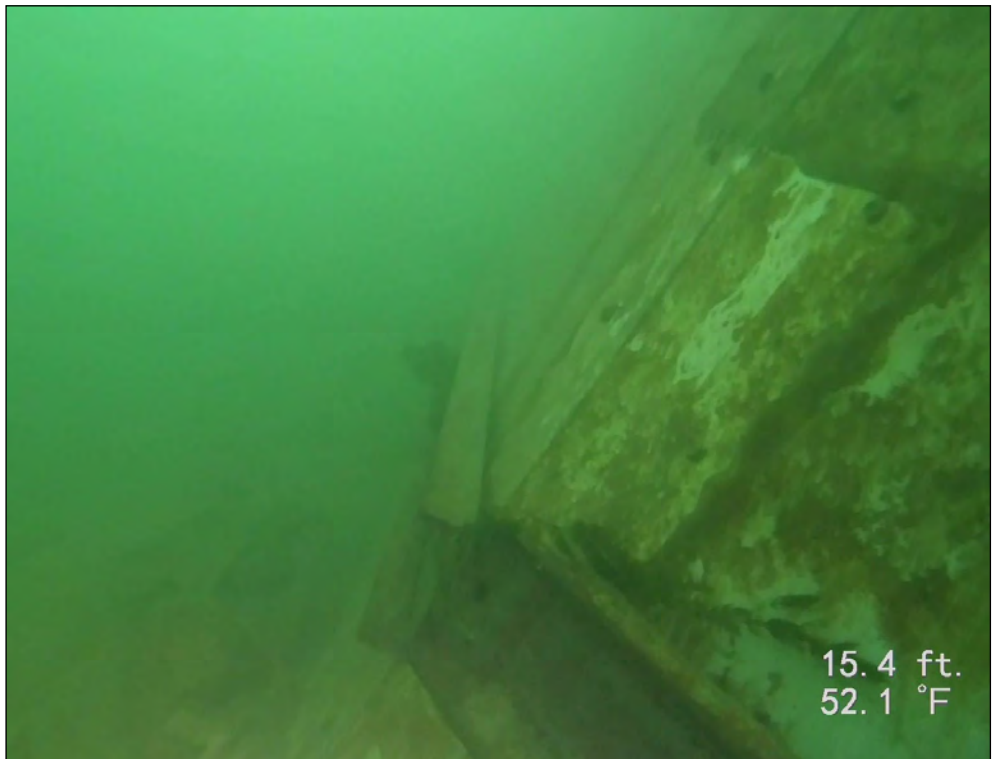
*Pier 10w, vinyl
sheeting and
steel walers,
typical*

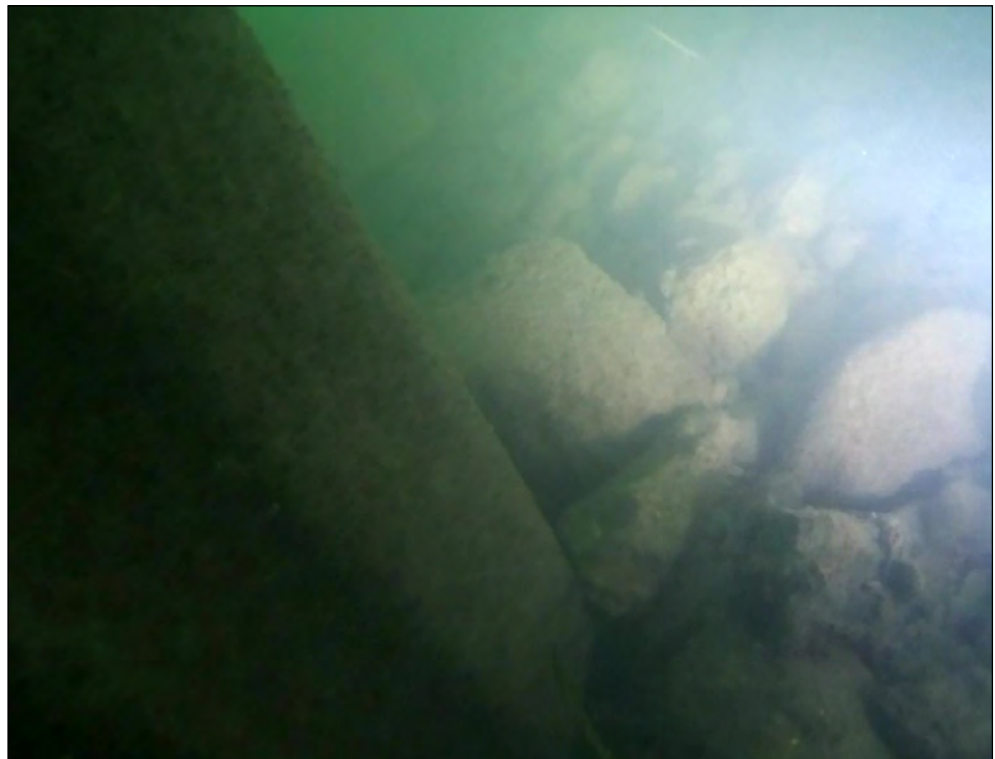
*Pier 11w,
footing
exposure and
channel
bottom, typical*
