# GROSSE ILE PARKWAY OVER TRENTON CHANNEL STRUCTURE NUMBER 12066 BRIDGE EVALUATION

AUGUST 2022

THE MANNIK & SMITH GROUP, INC.

Re: **Bridge Evaluation**

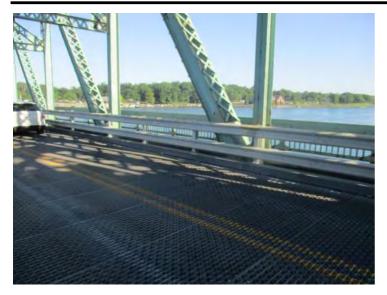
Document Name: IMG\_6908.JPG

Comments: Guardrail railing in spans 9W and 10W

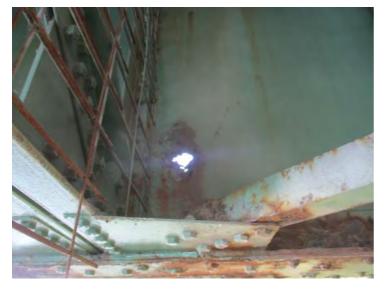
Document Name: IMG\_6922.JPG

Comments: Span 1W, south girder, 2"x3" hole in web btw FB 1W

and 2W

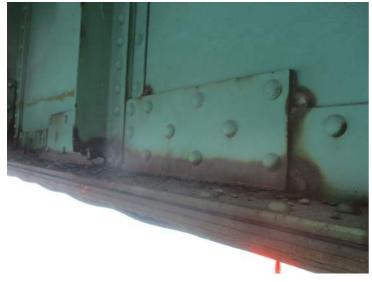
Document Name: IMG\_6930.JPG Category: Superstructure

Comments: Hole through web stiffener, typical

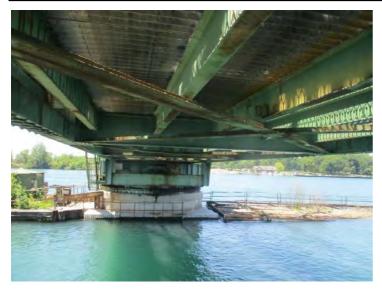
Document Name: IMG\_6954.JPG

Category: Substructure Span Number: Comments: Pier 9W

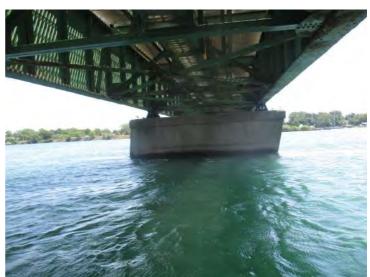
Comments: Pier 2W, east face

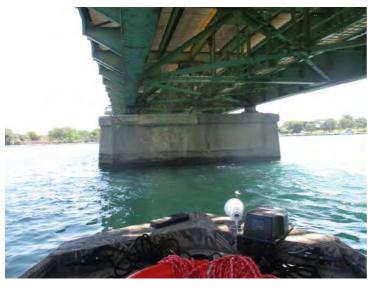
Category: Substructure Span Number: Comments: Pier 5W

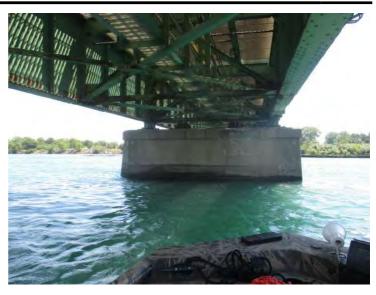
Category: Substructure Span Number: Comments: Pier 7W

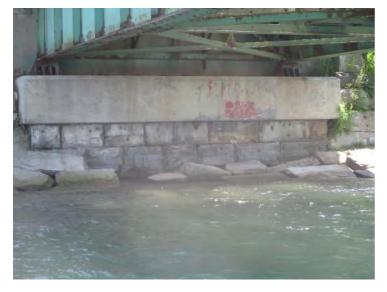
Comments: East abutment

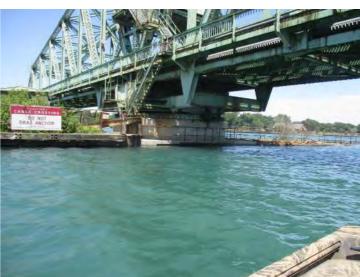
Span Number: Comments: Pier 9W

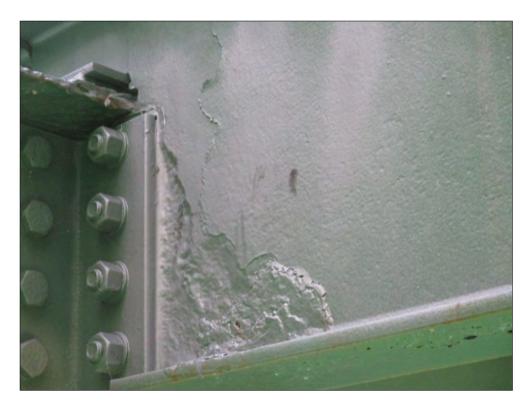
Span 2w, floorbeam 2w, bay 1w, stringer 1s, web loss of section

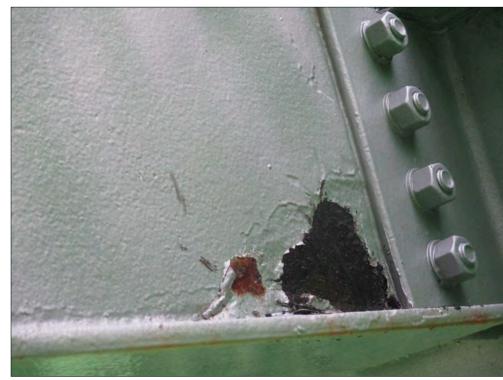
Span 2w, floorbeam 2w, bay 1w, stringer 2s, web loss of section

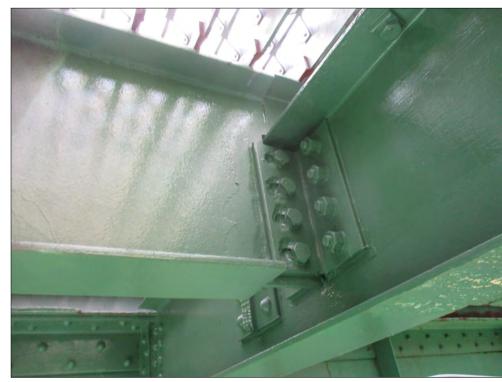
Span 7w,
Floorbeam/
stringer
connection,
bay 2w,
stringer 1s,
painted over
LOS

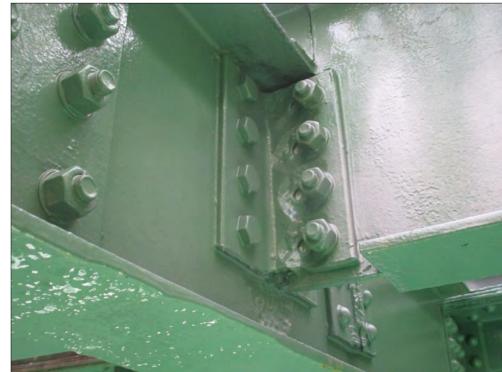
Span 7w, stringer 1s connection, bay 2w, stringer 1s, heavy LOS

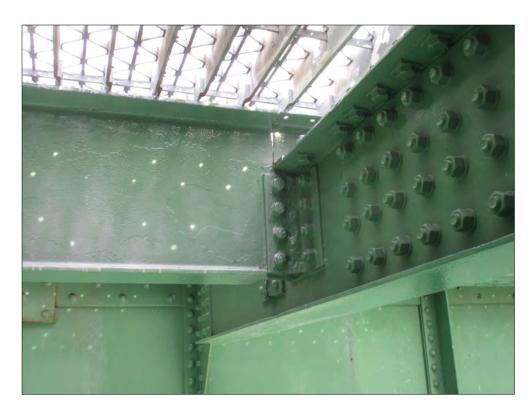
Span 7w, stringer 3s connection, bay 2w, stringer 1s, heavy LOS

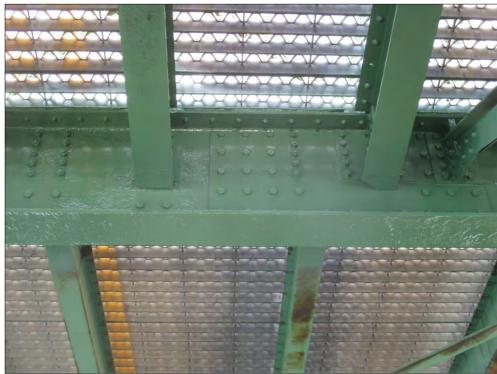
Span 9w, floorbeam 1w, bolted repair, stringer 2s

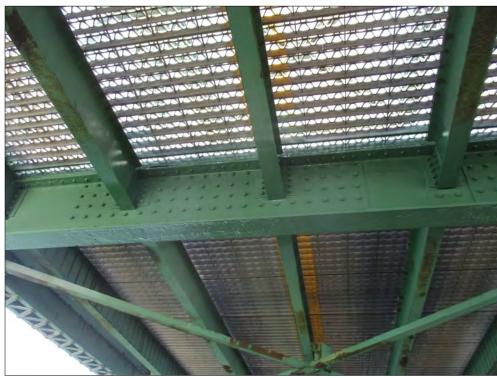
Span 9w, floorbeam 2w, bolted repair

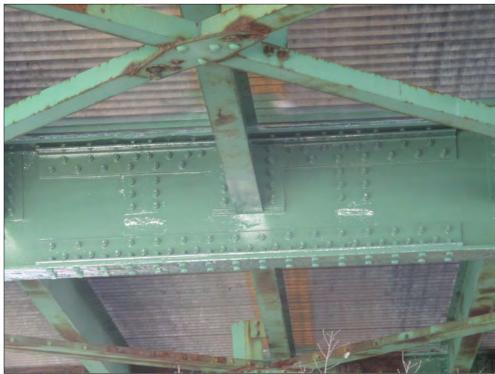
Span 9w, floorbeam 3w, bolted repair

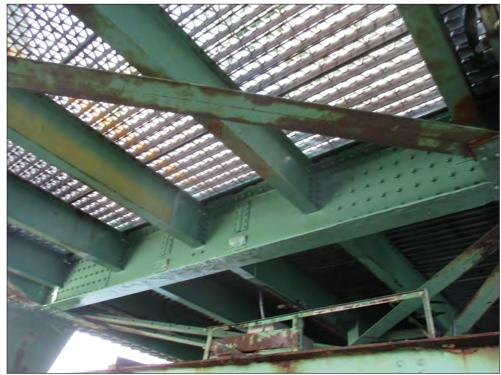
Span 9w, floorbeam 6w, bolted repair

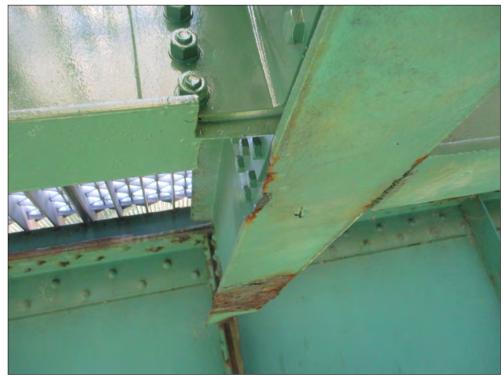
Span 11w, floorbeam 2w 1/2" wide hole at edge of bottom flange

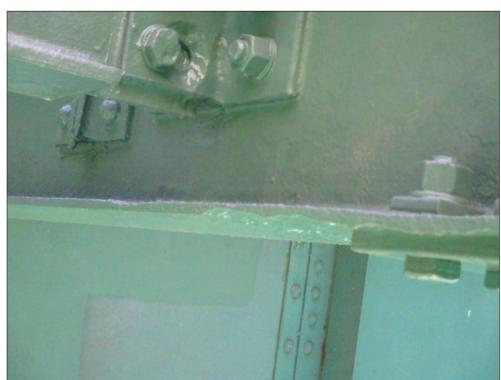
Span 12w, floorbeam 3w

Bottom flange thickness 0.22" adjacent to bolted repair

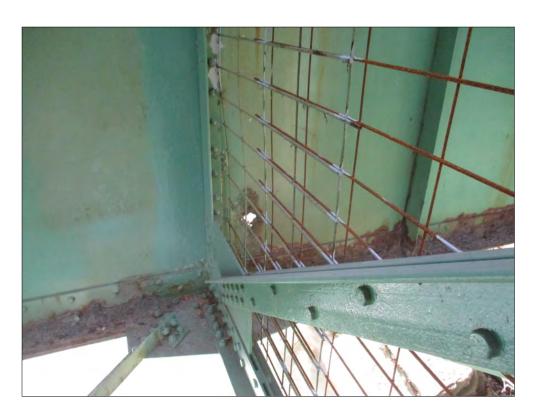
4 APPROACH SPANS: Griders: Heavy rust and scale at floorbeam connections and pack rust between bottom cover plates. Span 1W, south girder has a 5"x5" hole thru web at FB 2W and a 2"x3" hole thru web btw FB 1W and 2W. Noted holes thru web stiffeners in span 3W, 4W, 7W, 8W, 11W, and 12W. Floorbeams: most of floorbeams either repaired or replaced in 2007 or 2021. Original riveted floorbeam connections have packrust. Stringers: areas of heavy rust and section loss on stringers. Several stringer connections to repaired floorbeams have section loss. Lateral bracing: throughout bridge gusset plates for lateral bracing have holes and several lateral bracing member has holes and are broken.

Span 1w, south girder, floorbeam 2w, 5" x 5" hole in web

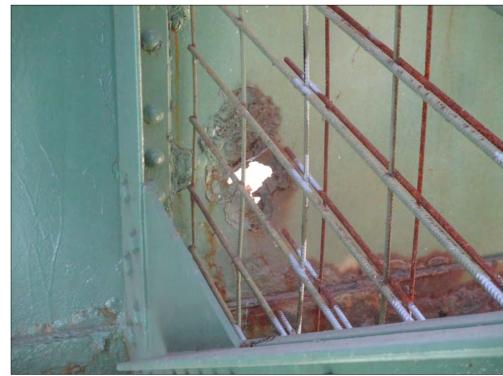
Span 1w, south girder, floorbeam 2w, 5" x 5" hole in web

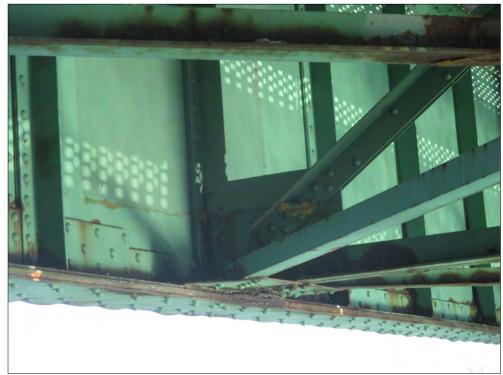
Span 2w, north girder, section loss at floorbeam 3w, 4w

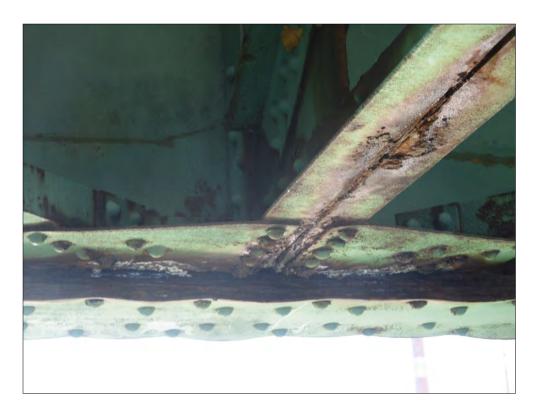
Span 3w, south girder, section loss at floorbeam 3w, 4w

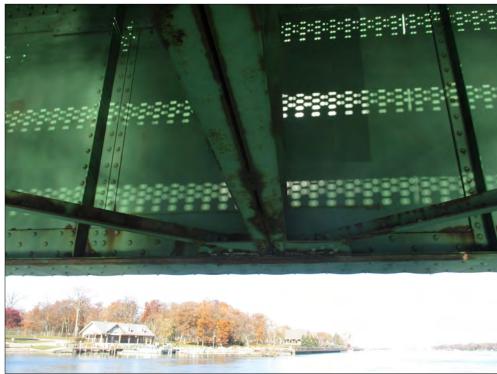
Span 3w, north girder, section loss at floorbeam 3w, 4w

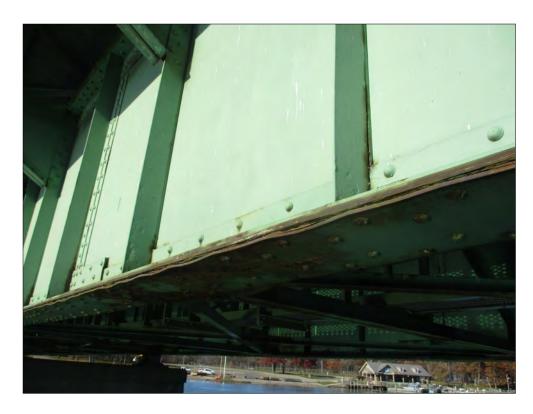
Span 4w, south girder, section loss at floorbeam 3w, 4w

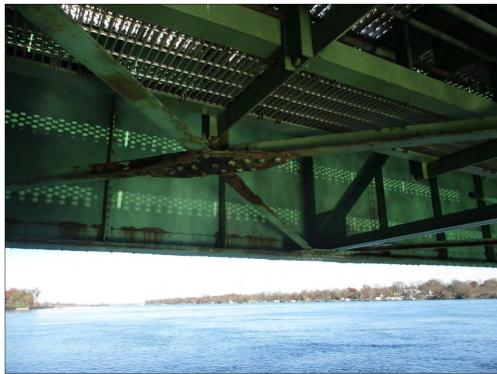
Span 4w, north girder, section loss at floorbeam 3w, 4w

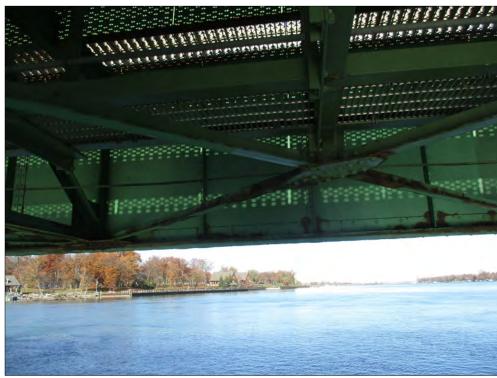
Span 5w, north girder, section loss at floorbeam 3w, 4w

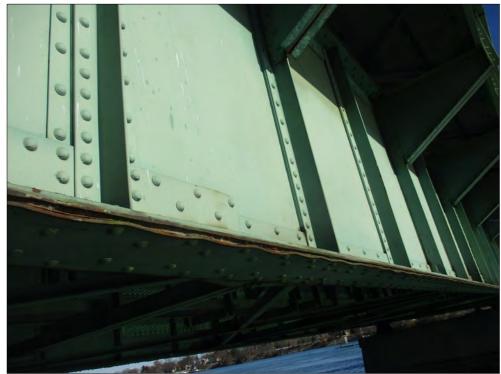
Span 6w, north girder, section loss at floorbeam 3w, 4w

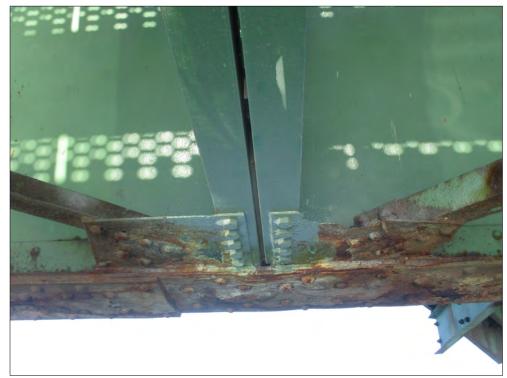
Span 7w, north girder, bottom flange, floorbeam 5w

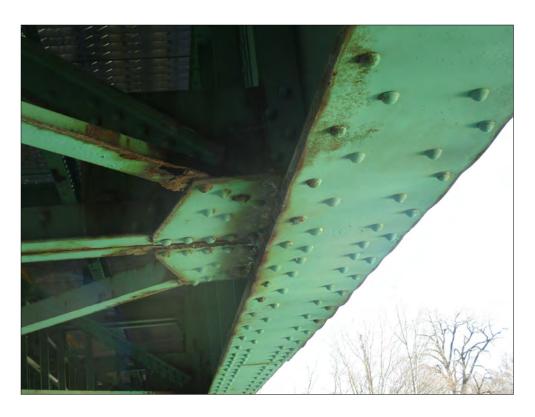
Span 11w, south girder, section loss at floorbeam 3w, 4w

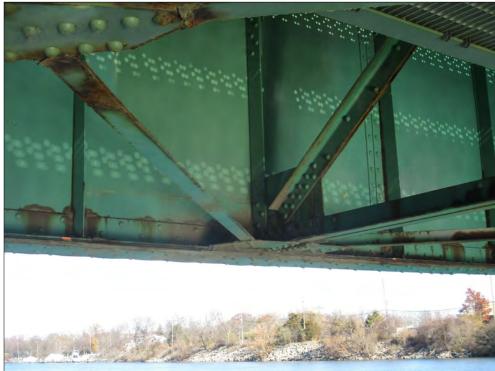
Span 11w, north girder, section loss at floorbeam 3w, 4w

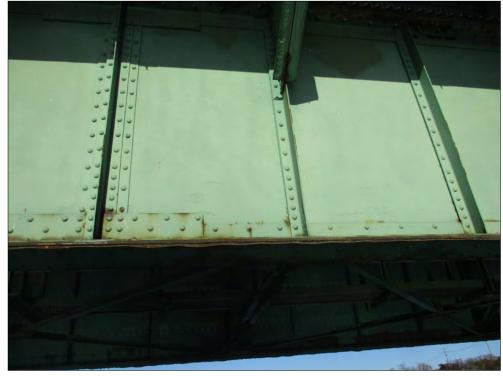
Span 12w, north girder, section loss at floorbeam 3w, 4w

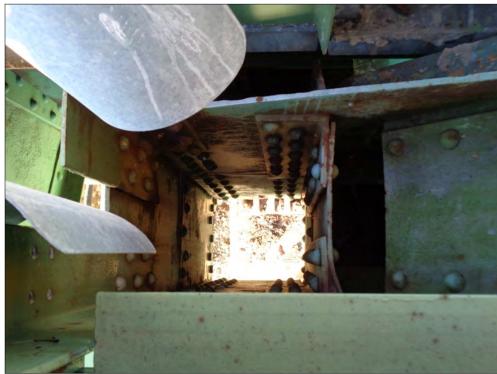
Span 9w, south truss, lower gusset, north plate  $L_0$  holes

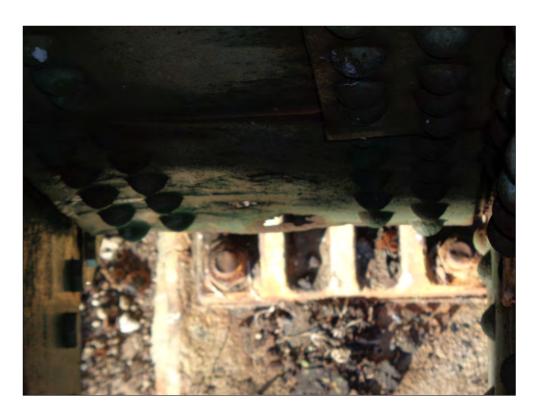
Span 9w, south truss, lower gusset, north plate  $L_0$  holes

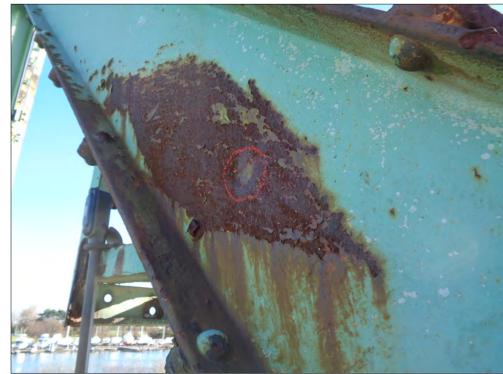
Span 9w, south truss, north face, diagonal  $L_0$  -  $U_1$  section loss

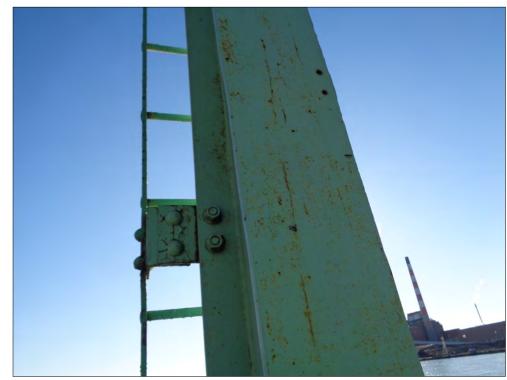
Span 9w, south truss, north face, vertical L<sub>1</sub> - U<sub>1</sub> rust crack

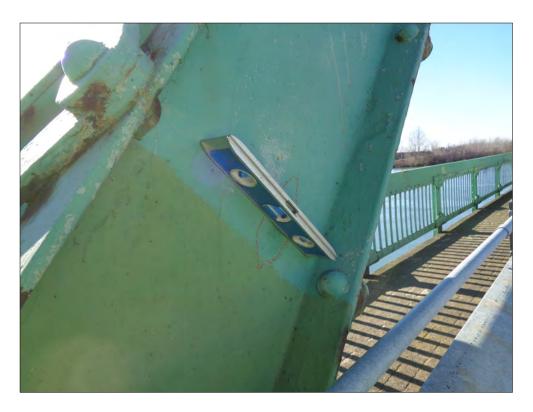
Span 9w, south truss, north face, diagonal  $U_2$  -  $L_3$ section loss

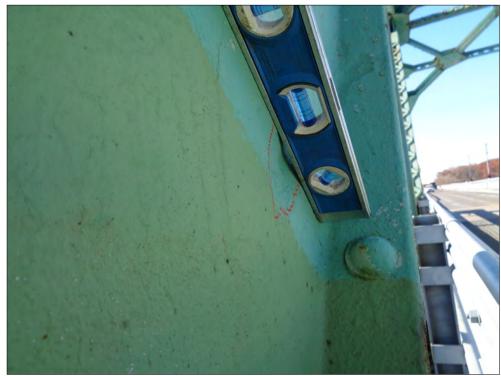
Span 9w, south truss, north face, diagonal  $U_2 - L_3$ section loss

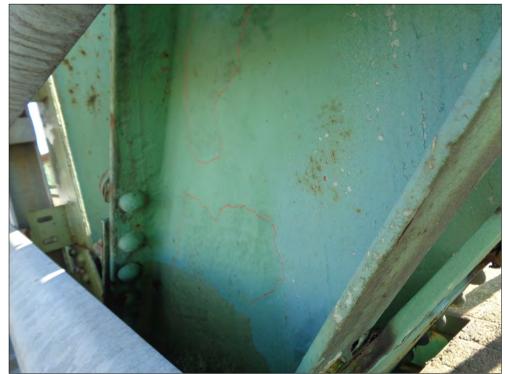
Span 9w, south truss, north face, diagonal  $U_3$  -  $L_4$ section loss

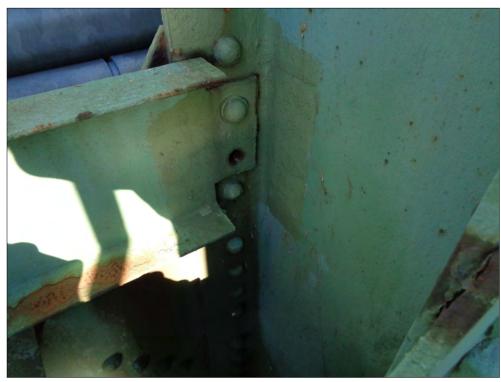
Span 9w, south truss, north face, lower gusset, vertical  $L_4$  -  $U_4$ missing rivets

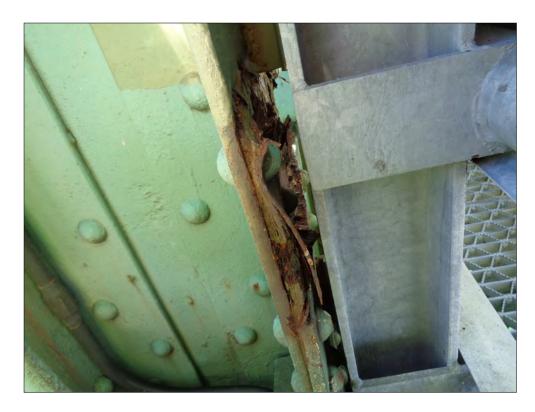
Span 9w, south truss, north face, lower gusset, vertical  $L_6$  -  $U_6$  pack rust

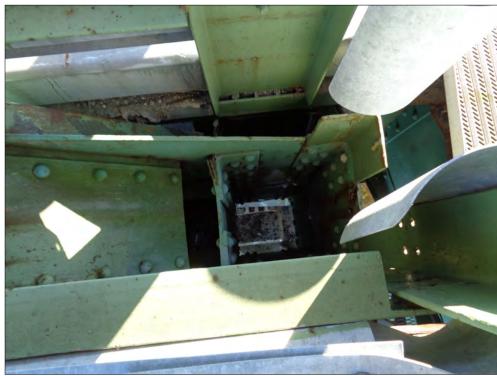
Span 9w, north truss, lower gusset, south plate, L<sub>0</sub>, holes

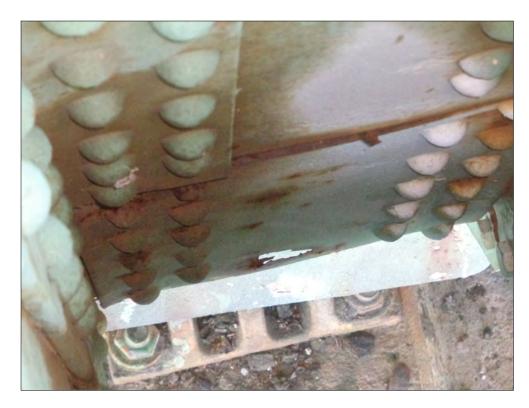
Span 9w, north truss, lower gusset, south plate, L<sub>0</sub>, holes

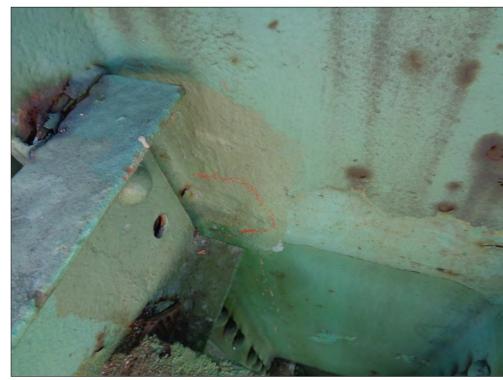
Span 9w, north truss, east face, web, vertical  $L_1$  -  $U_1$ section loss

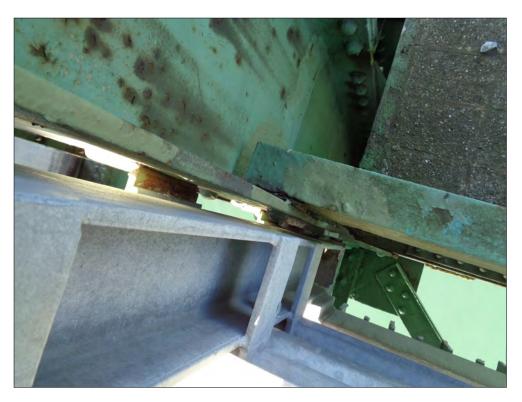
Span 9w,
north truss,
east leg,
south flange,
vertical
L<sub>1</sub> - U<sub>1</sub>
section loss

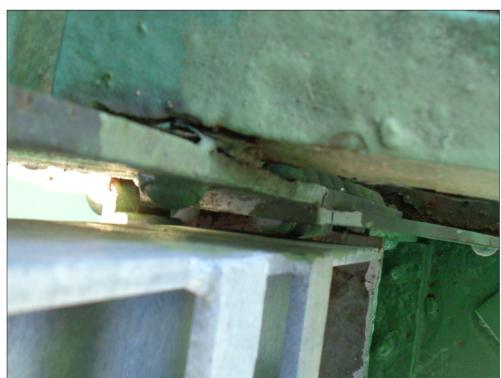
Span 9w,
north truss,
east leg,
south flange,
vertical
L<sub>1</sub> - U<sub>1</sub>
section loss

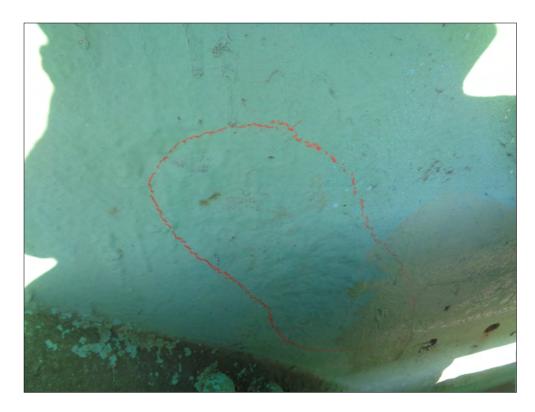
Span 9w, north truss, south face, diagonal  $U_1$  -  $L_2$ section loss

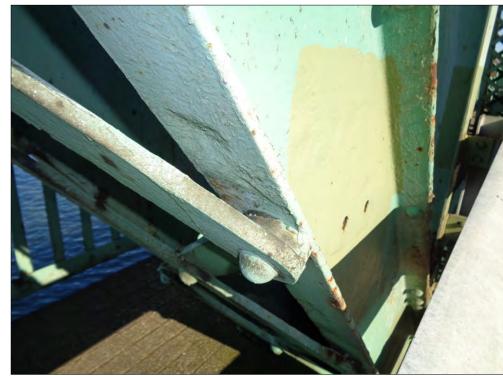
Span 9w, north truss, south face, diagonal  $U_2$  -  $L_3$ section loss

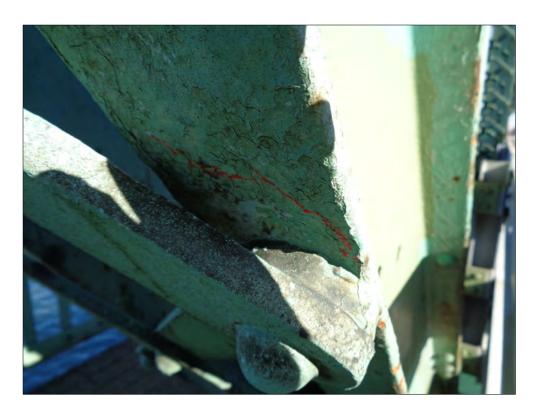
Span 9w, north truss, south face, diagonal  $U_2$  -  $L_3$ section loss

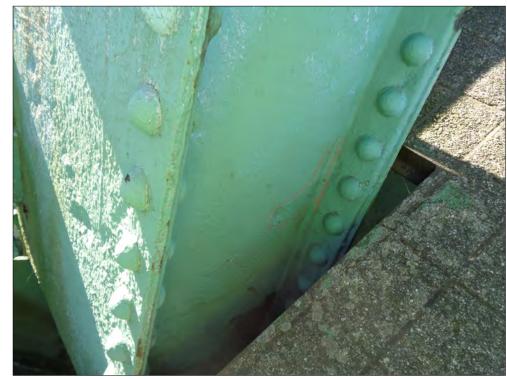
Span 9w, north truss, north face, diagonal  $U_3$  -  $L_4$ section loss

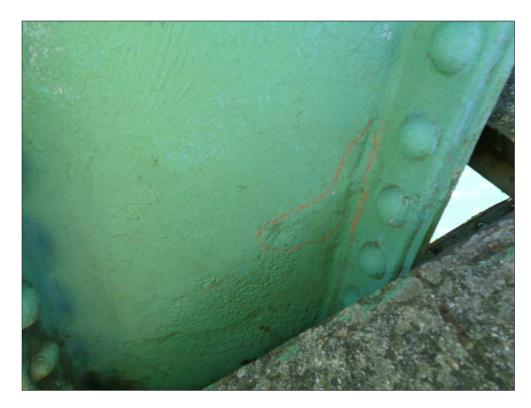
Span 9w, north truss, north face, diagonal U<sub>3</sub> - L<sub>4</sub> section loss

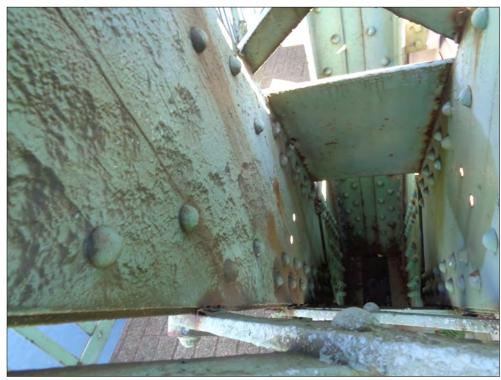
Span 9w, north truss, north face, diagonal  $U_5$  -  $L_6$ section loss

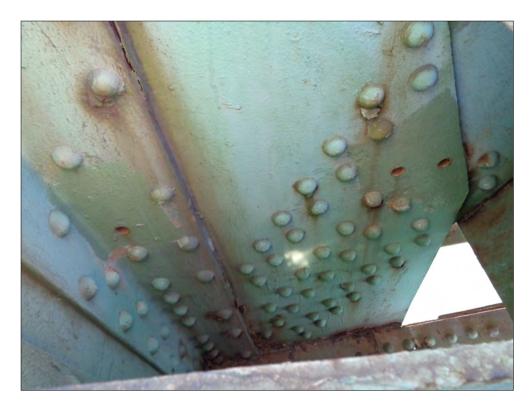
Span 9w, north truss, south face, lower gusset  $L_6$  -  $U_6$ missing rivets

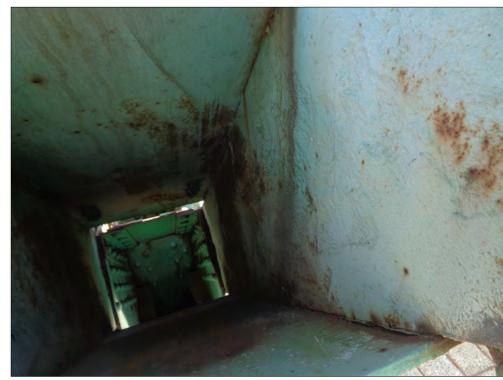
Span 10w, south truss, north face, diagonal  $U_I$  -  $L_\theta$  section loss

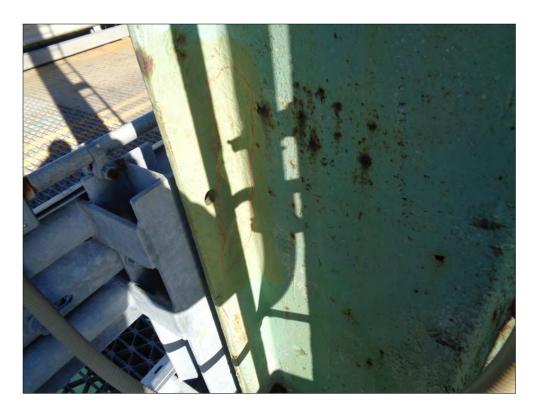
Span 10w, south truss, north face, vertical  $U_I - L_I$  section loss

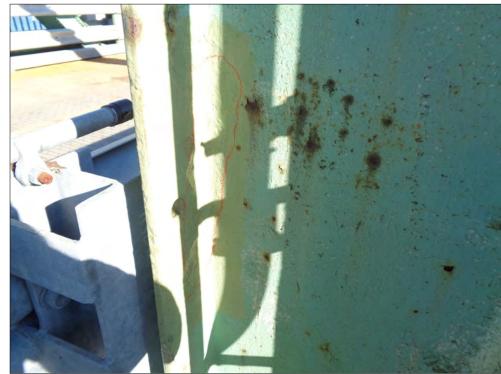
Span 10w, south truss, north face, vertical  $U_1$  -  $L_1$  section loss

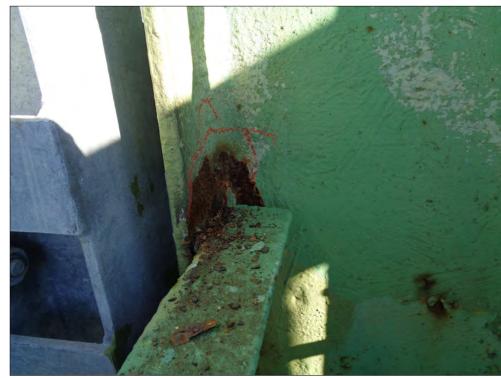
Span 10w, south truss, north face, vertical  $U_I$  -  $L_I$  section loss

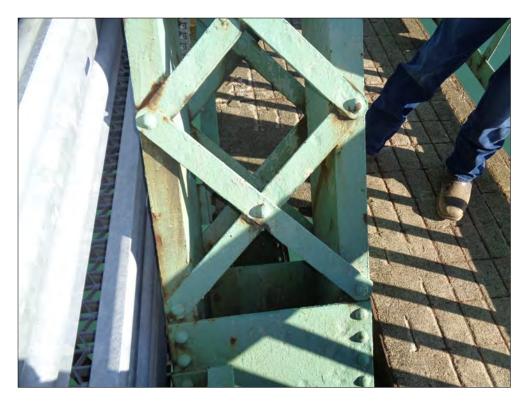
Span 10w, south truss, south face, diagonal  $U_2$  -  $L_1$ section loss

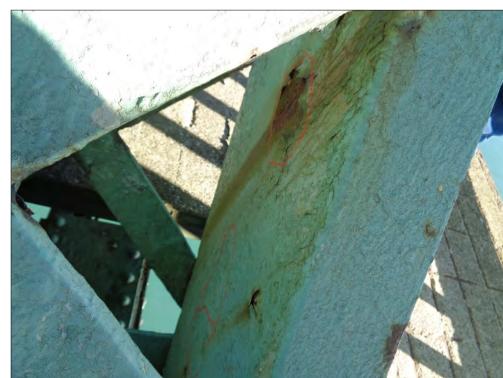
Span 10w, south truss, south face, diagonal  $U_2$  -  $L_1$  section loss

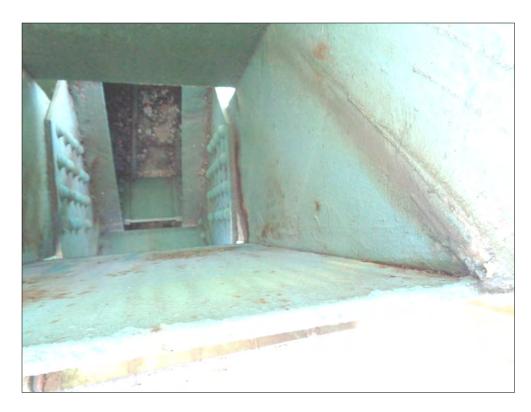
Span 10w, south truss, north face, diagonal  $U_2$  -  $L_1$  section loss

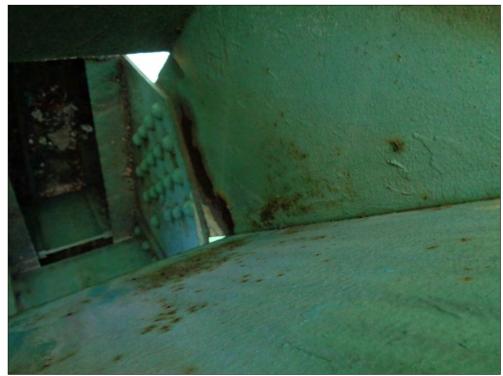
Span 10w, south truss, north face, diagonal  $U_2$  -  $L_1$  section loss

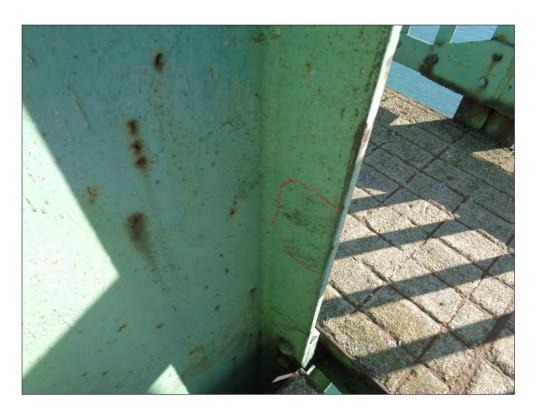
Span 10w, south truss, north face, vertical  $U_2$  -  $L_2$ section loss

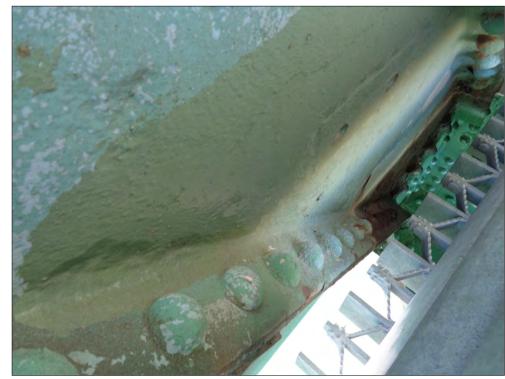
Span 10w, south truss, north face, diagonal U<sub>3</sub> - L<sub>2</sub> section loss

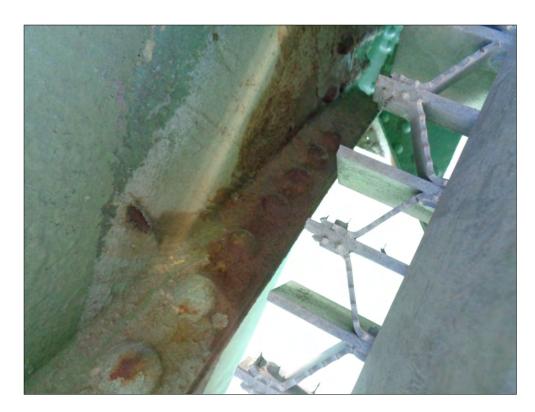
Span 10w, south truss, north face, diagonal U<sub>3</sub> - L<sub>2</sub> section loss

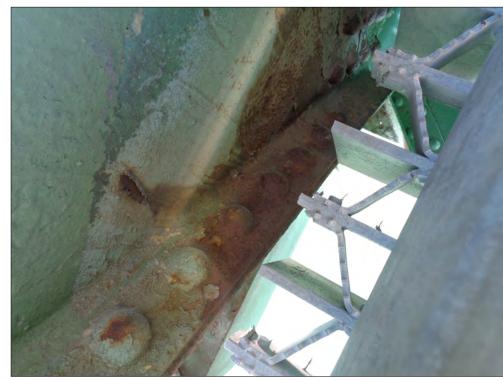
Span 10w, south truss, north face, diagonal U<sub>3</sub> - L<sub>2</sub> section loss

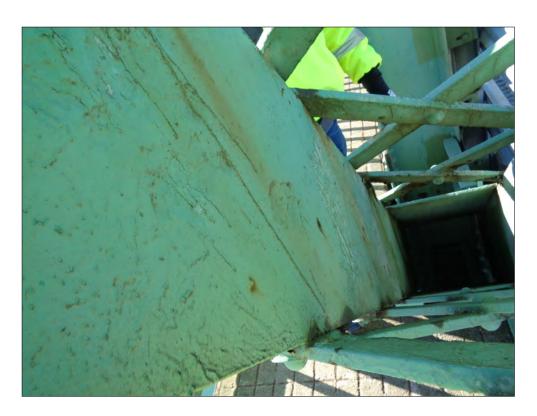
Span 10w, south truss, north face, diagonal U<sub>4</sub> - L<sub>3</sub> section loss

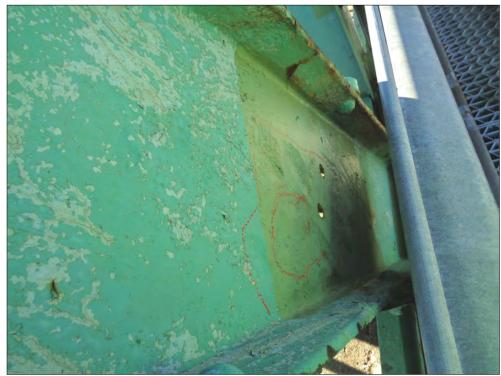
Span 10w, south truss, north face, diagonal  $U_4$  -  $L_3$ section loss

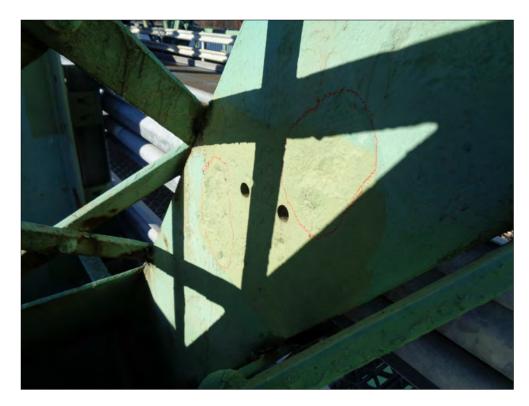
Span 10w, south truss, south face, diagonal  $U_4$  -  $L_3$ section loss

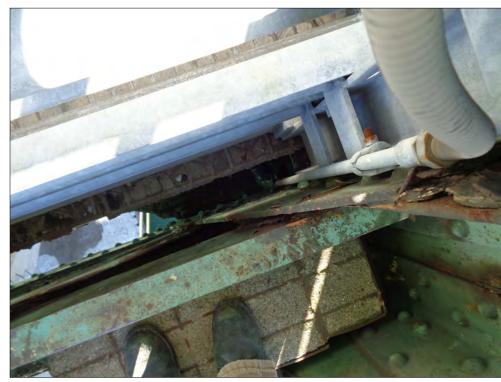
Span 10w, south truss, north gusset, vertical  $U_6$  -  $L_6$  section loss

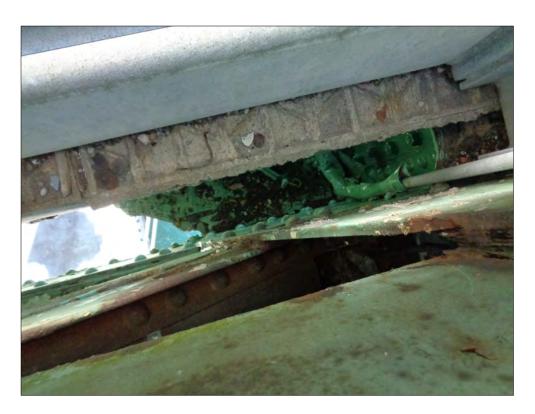
Span 10w, south truss, north gusset, vertical  $U_6$  -  $L_6$ section loss

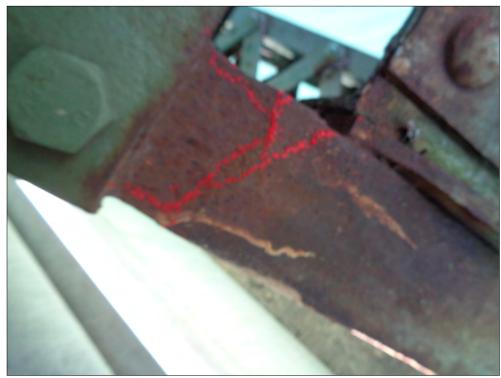
Span 10w, north truss, north face, diagonal  $L_{\theta}$  -  $U_{I}$  section loss

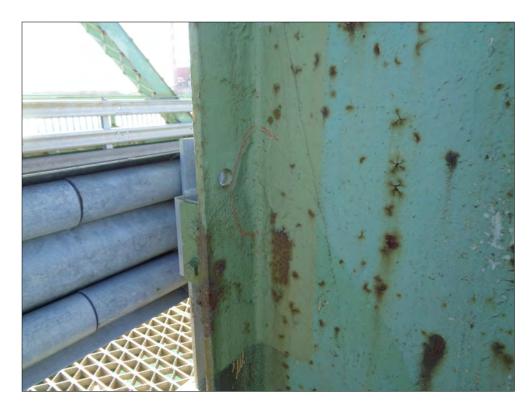
Span 10w, north truss, south face, vertical  $L_1$  -  $U_1$  section loss

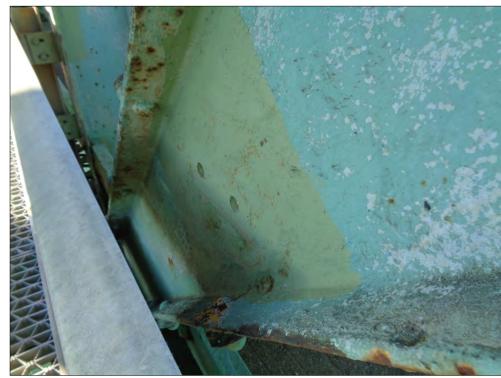
Span 10w, north truss, south face, diagonal  $U_1$  -  $L_2$  section loss

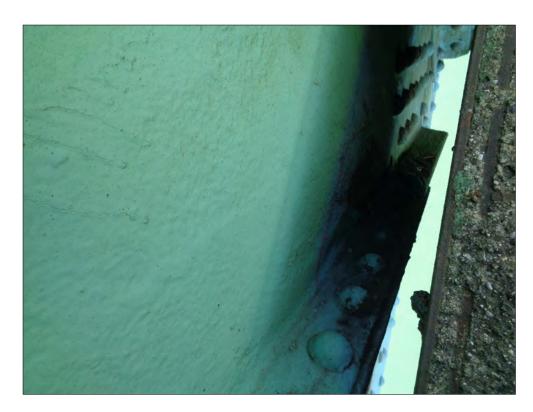
Span 10w, north truss, north face, diagonal  $U_4$  -  $L_3$ section loss

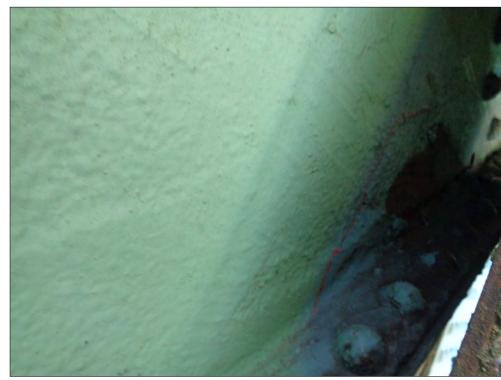
Span 10w, north truss, north face, diagonal  $U_4$  -  $L_3$ section loss

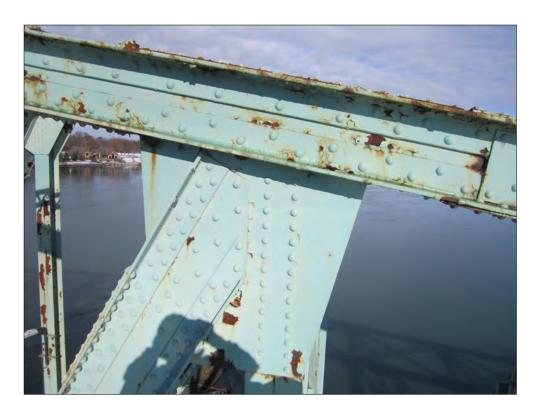
Span 10w, south truss, south face, gusset plate U<sub>5</sub>

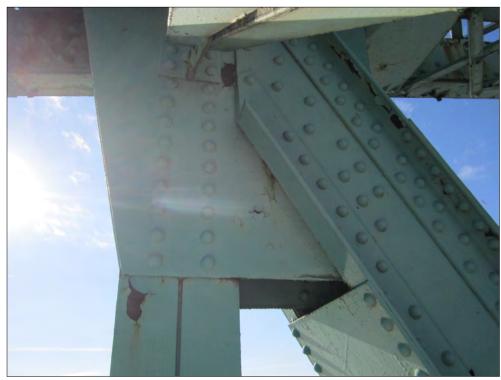
Span 10w, south truss, north face, gusset plate U<sub>5</sub>

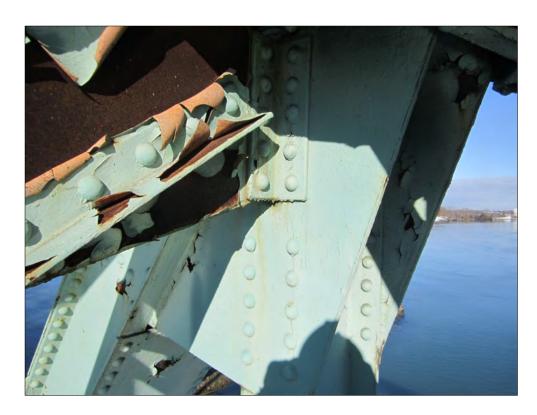
Span 10w, north truss, south face, gusset plate U<sub>3</sub>

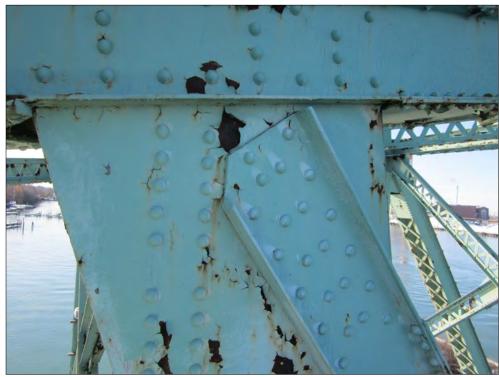
Span 10w, north truss, north face, gusset plate U<sub>3</sub>

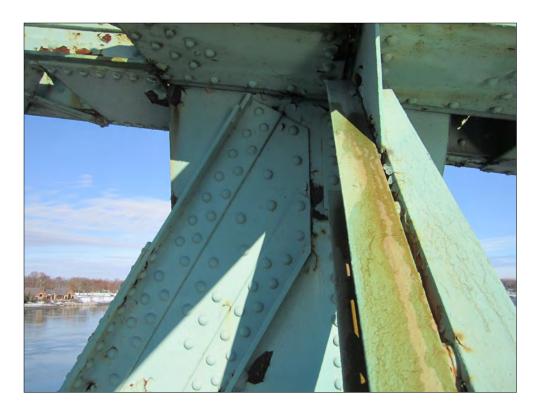
Span 10w, north truss, south face, gusset plate U<sub>5</sub>

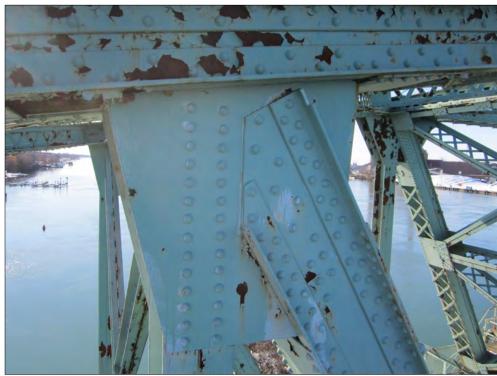
Span 10w, north truss, north face, gusset plate U<sub>5</sub>

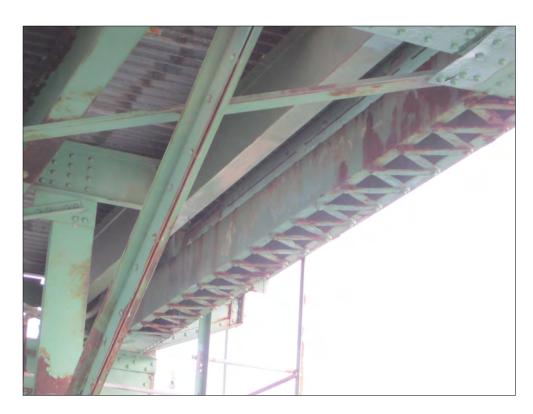
Span 10w, south truss, bottom chord,  $L_0$  -  $L_1$

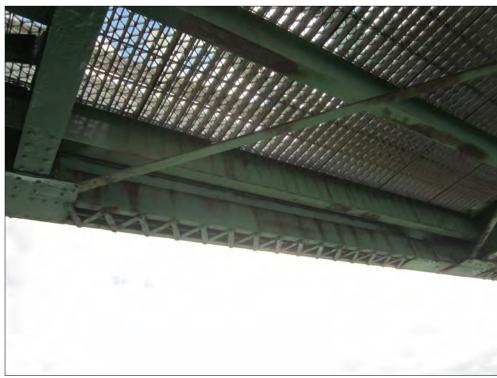
Span 10w, south truss, bottom chord,  $L_1$  -  $L_2$

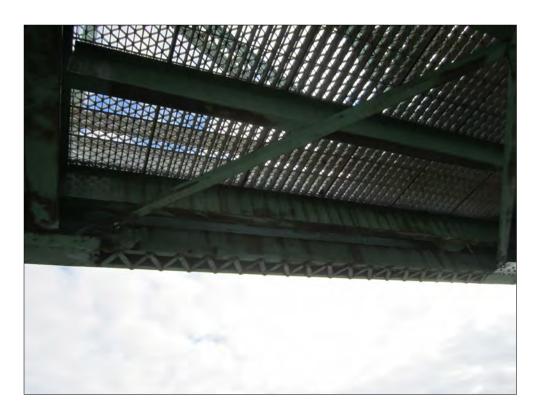
Span 10w, south truss, bottom chord,  $L_2$  -  $L_3$

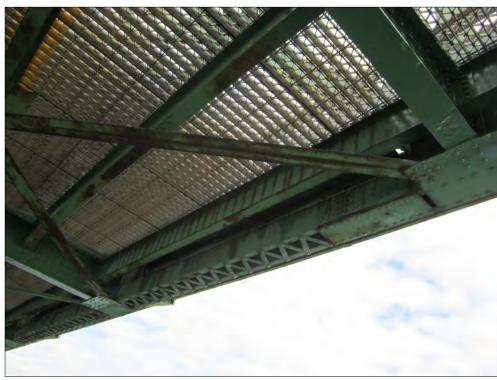
Span 10w, south truss, bottom chord,  $L_3$  -  $L_4$

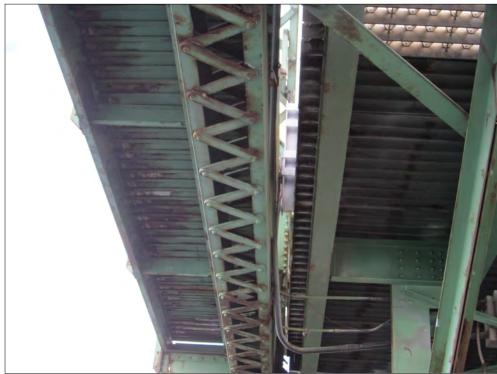
Span 10w, north truss, bottom chord,  $L_0$  -  $L_1$

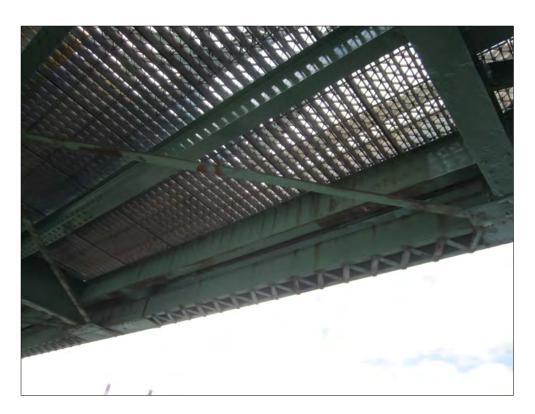
Span 10w, south truss, bottom chord,  $L_1$  -  $L_2$

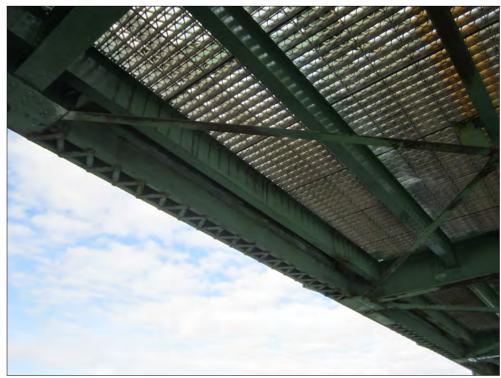
Span 10w, north truss, bottom chord, L<sub>2</sub> - L<sub>3</sub>

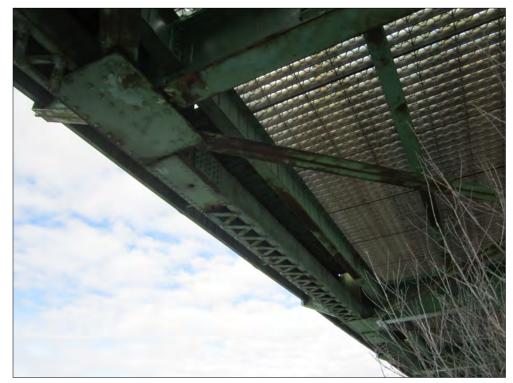
Span 10w, north truss, bottom chord, L<sub>4</sub> - L<sub>5</sub>
