**UNDERWATER BRIDGE INSPECTION REPORT
GROSSE ILE PARKWAY OVER
TRENTON CHANNEL
STR 12006**

WAYNE COUNTY

NOVEMBER 9, 2021

GLEG FILE No: 1020-2-704

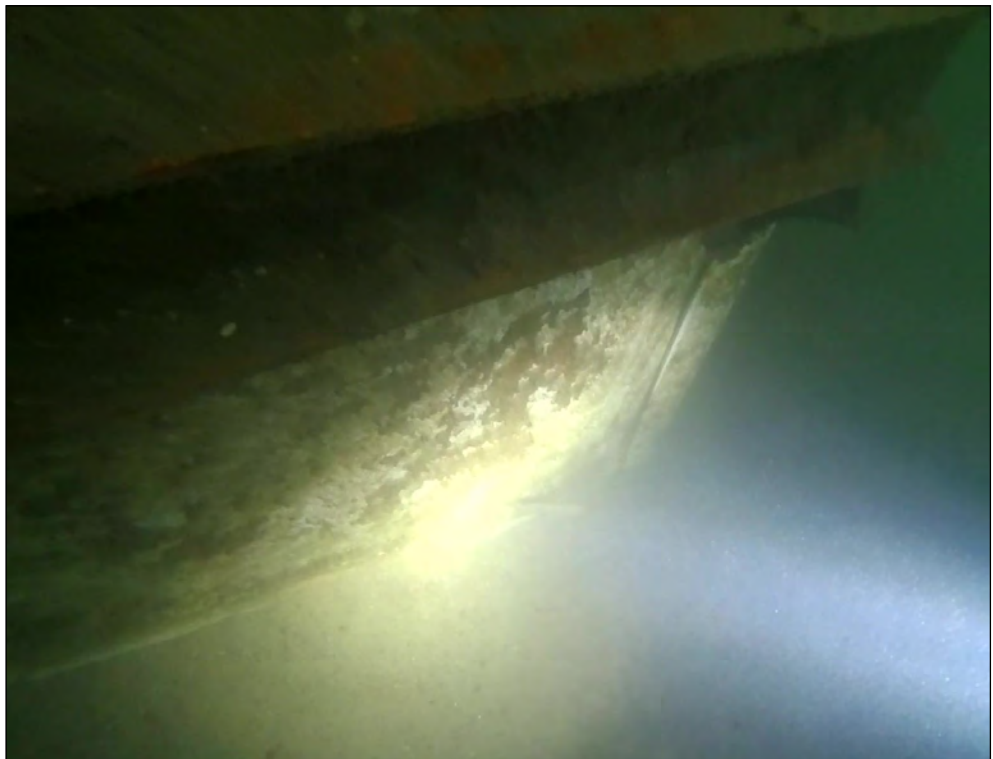
*Pier 2w, vinyl
sheeting and
steel waler,
typical*

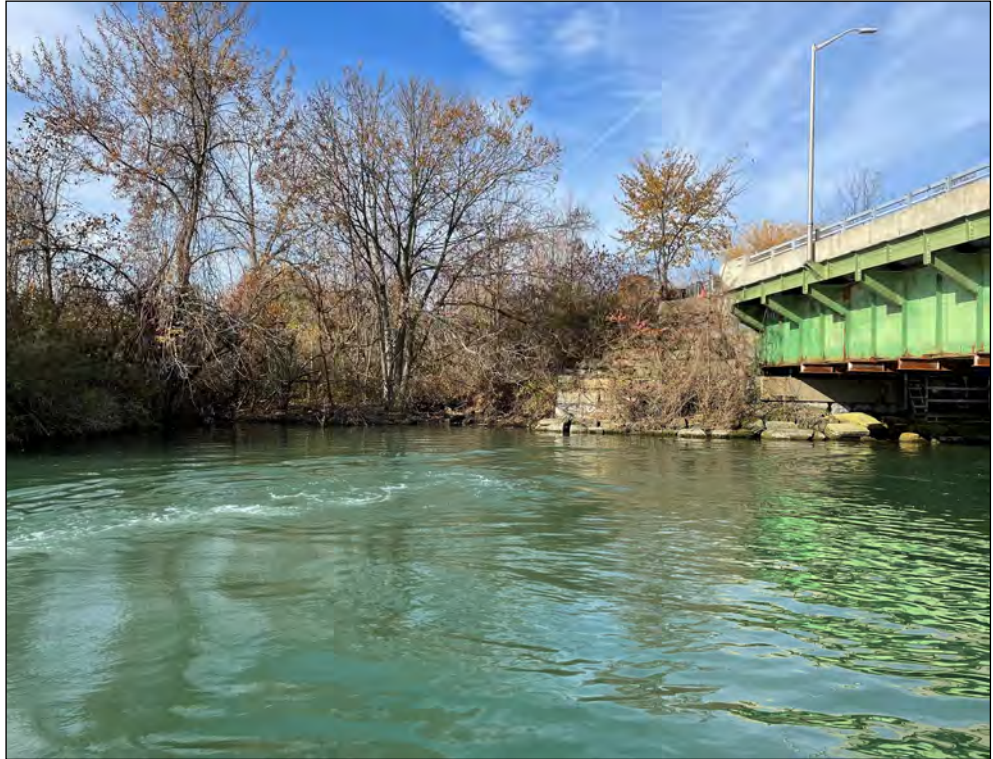
*Southwest
channel bank*

The west channel banks are natural with no slope protection in place. The east channel banks have stacked stone blocks in place to retain the approach slopes. Farther from the bridge, there is a boat launch in the northwest quadrant and a marina in the southeast quadrant. No erosion or significant debris was found at the bridge.
